Re: Water Use Inspection Report, Water Licence W2007L2-0003

INDUSTRIAL WATER USE INSPECTION REPORT

DATE: <i>November 28th, 2011</i>	COMPANY REP(S): <i>David Wells</i>
LICENSEE: <i>Diavik Diamond Mines Inc.</i>	LICENCE #: <i>W2007L20003</i>

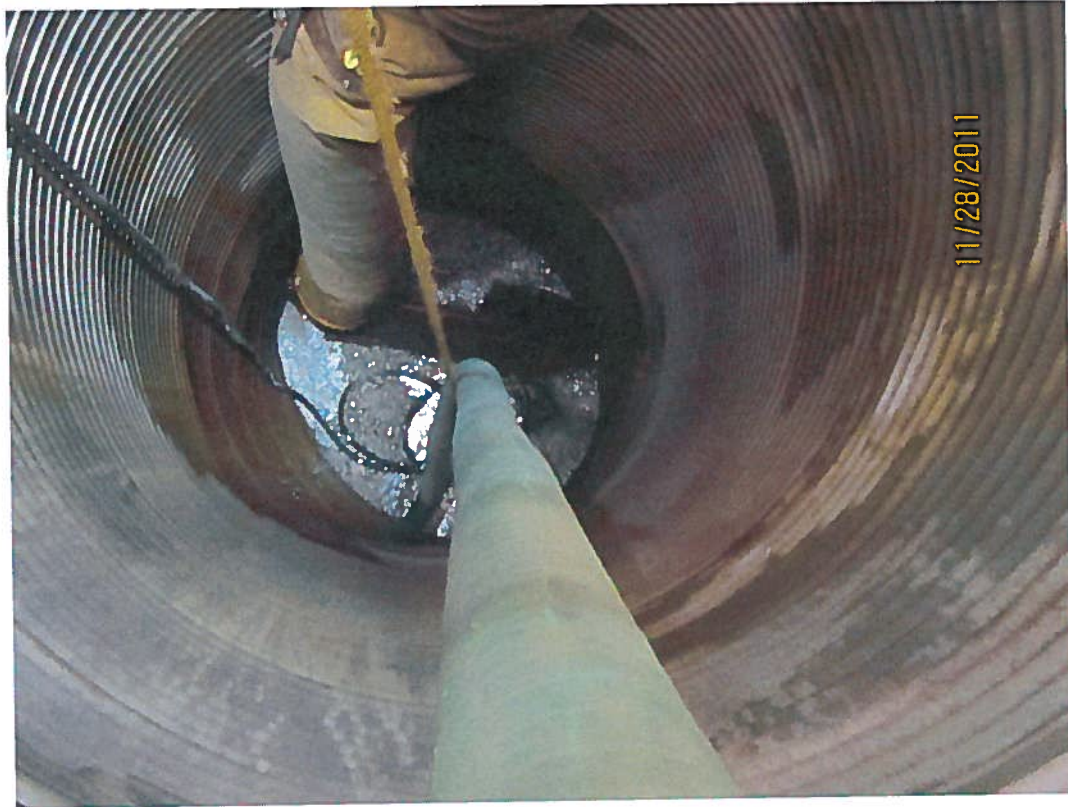
- No environmental concerns were noted with the Pump House.
- Figure 1 shows seepage flows in the well at "EPKC Sump 1". At the time of inspection, this water was being pumped back to the PKC Facility (as per Part H of the W.L.) at a rate of 1.5 L/sec (down from 4.5 L/s in mid October).

*¹ Figure 1 shows seepage flows in the well at "EPKC Sump 1". At the time of inspection, this water was being pumped back to the PKC Facility (as per Part H of the W.L.) at a rate of 1.5 L/sec (down from 4.5 L/s in mid October).

Figure 1. Seepage flows in the well at “EPKC Sump 1”. At the time of inspection, this water was being pumped back to the PKC Facility (as per Part H of the W.L.) at a rate of 1.5 L/sec (down from 4.5 L/s in mid October). The green hose (photo bottom) is the hose returning seepage water to the PKC. The large yellow duct (photo top) is directing hot air into the hole to keep the seepage water from freezing.

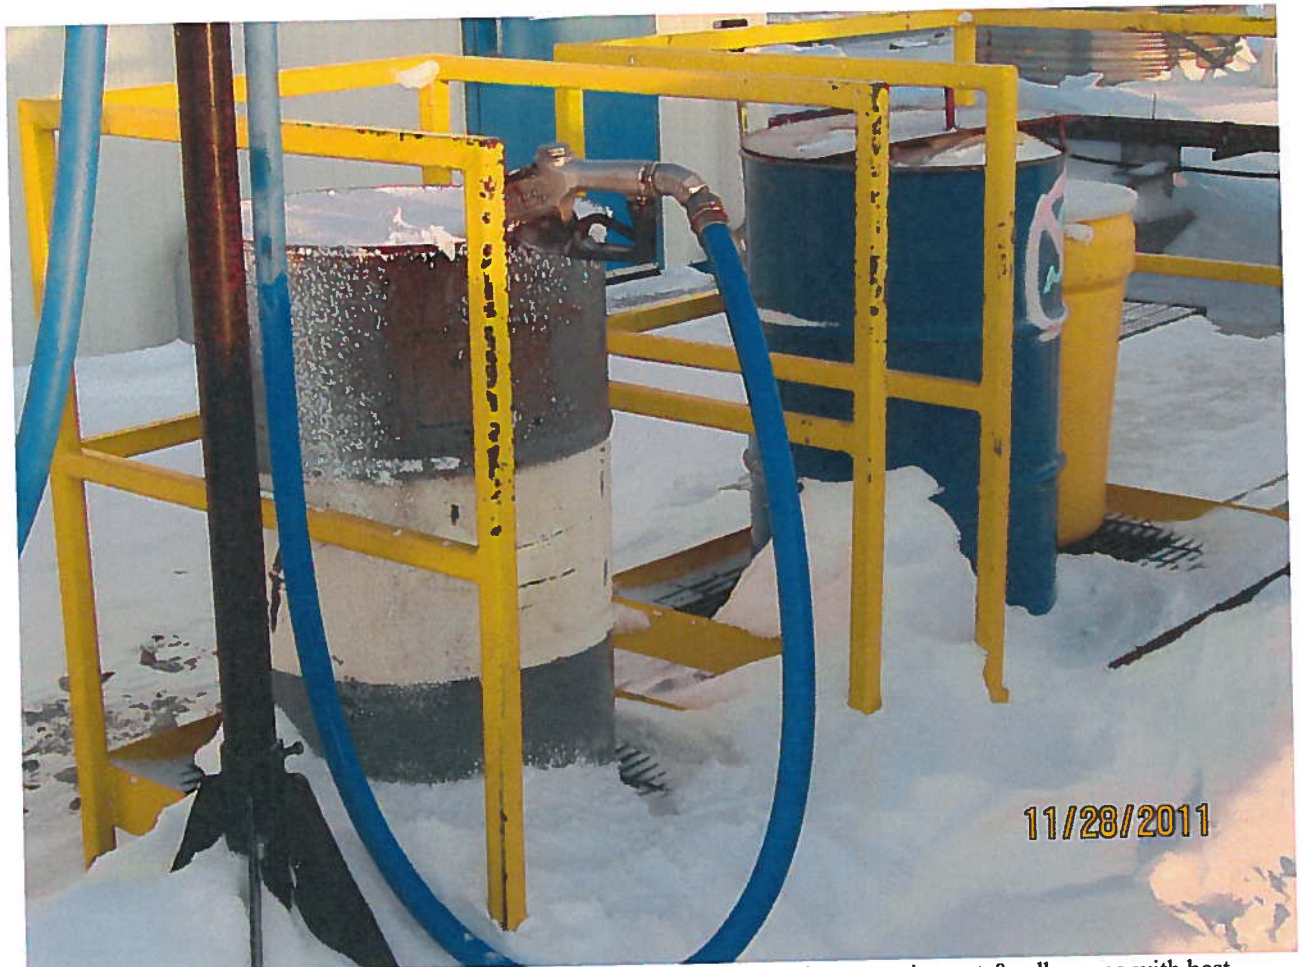
* Figure 2 shows effective fuel management at the fuel transfer facility (secondary containment & adherence with best practices).

Figure 2. Effective fuel management at the fuel transfer facility (secondary containment & adherence with best practices).

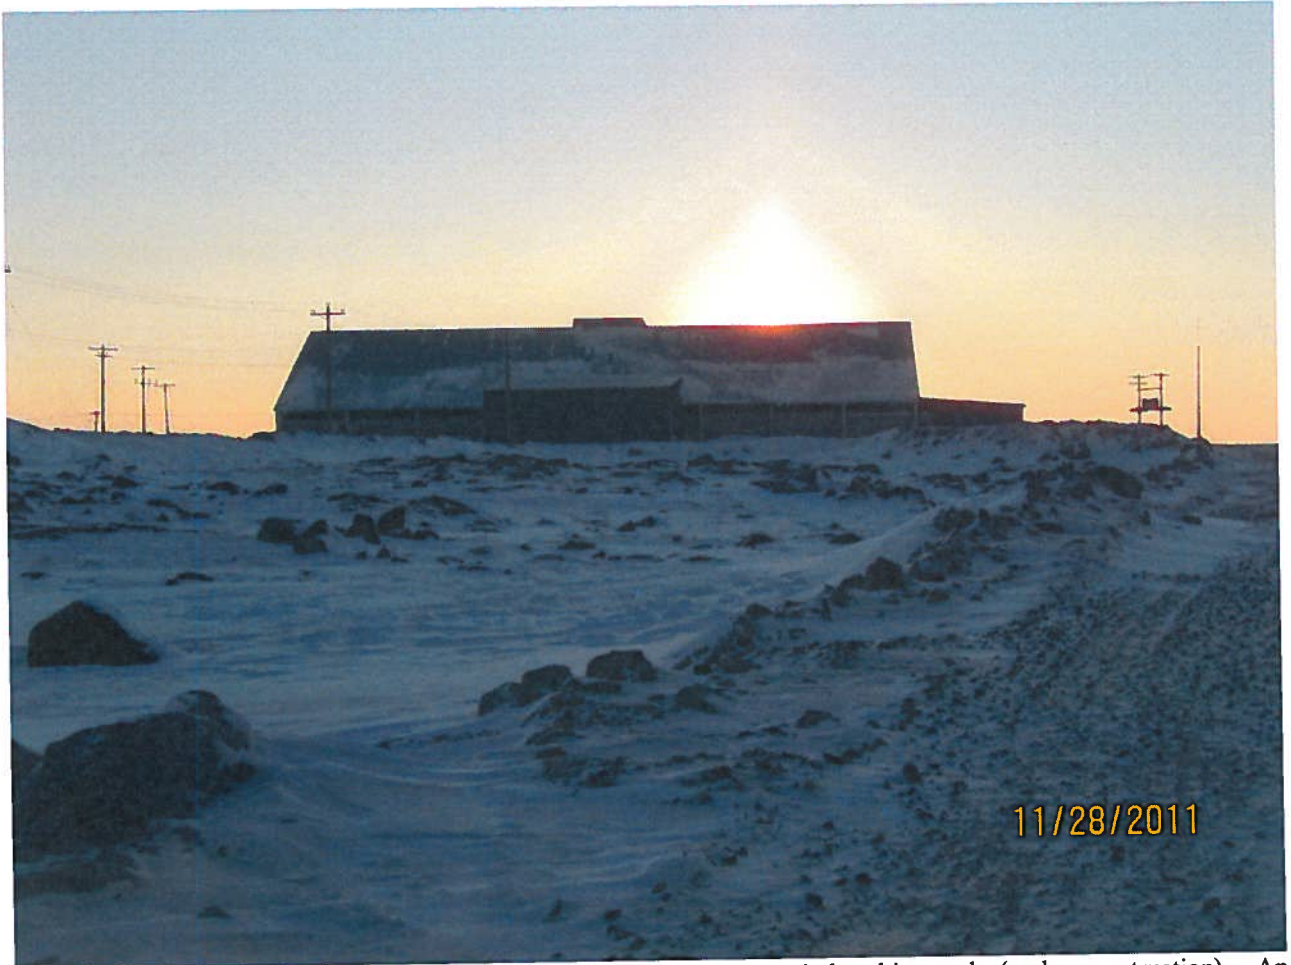
- Figure 3 shows the AN storage building at the time of the inspection. No environmental concerns were noted.

Figure 3. AN storage building as viewed from one of the new wind turbine pads (under construction). An inspection of the building showed no environmental concerns (it was being operated as per best practices, with AN stored below the height of the cement walls).
