November 24<sup>th</sup>, 2011

**Re: November 15<sup>th</sup>, 2011 AANDC Water Licence Inspection**

## INDUSTRIAL WATER USE INSPECTION REPORT

LICENCE #: W2009L2-0001 (Water Licence)  
Ekati Diamond Mine

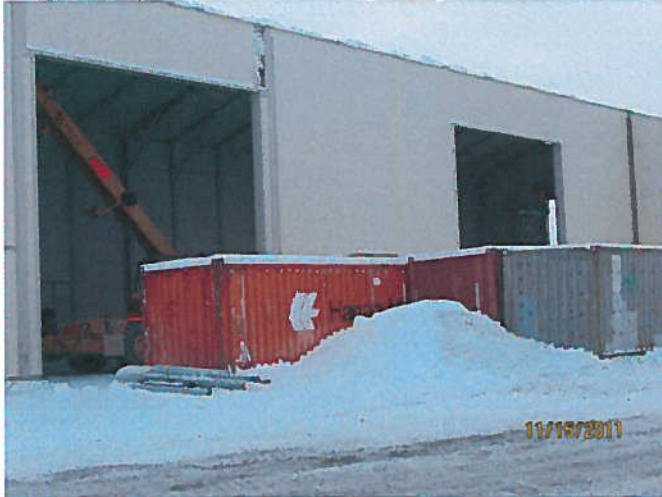
**Photo 1**

- A new Truck & Heavy Equipment Maintenance Shop had been erected at the Misery Camp Facilities site (See Photo 1).
- Recycling was observed at several locations within the Misery Camp (see Photo 2).

View of the new Truck & Heavy Equipment Maintenance Shop recently erected at the Misery Camp Facilities site.

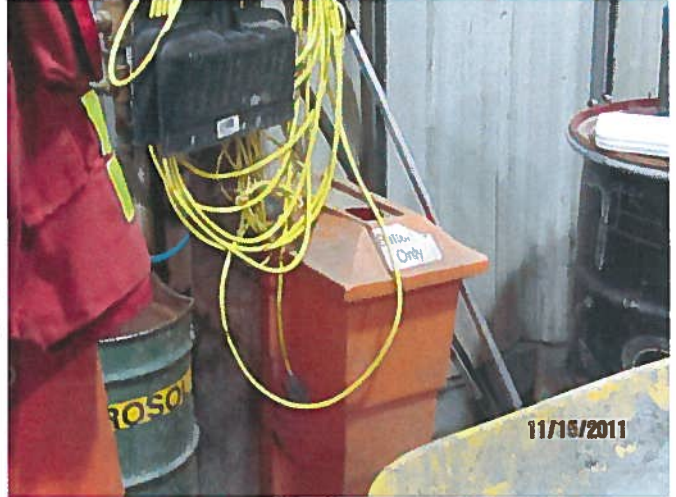
**Photo 2**

View of recycling observed in the office complex at the Misery Camp Facilities site. Recyclable material appeared to be effectively removed from the waste stream at throughout the Camp.

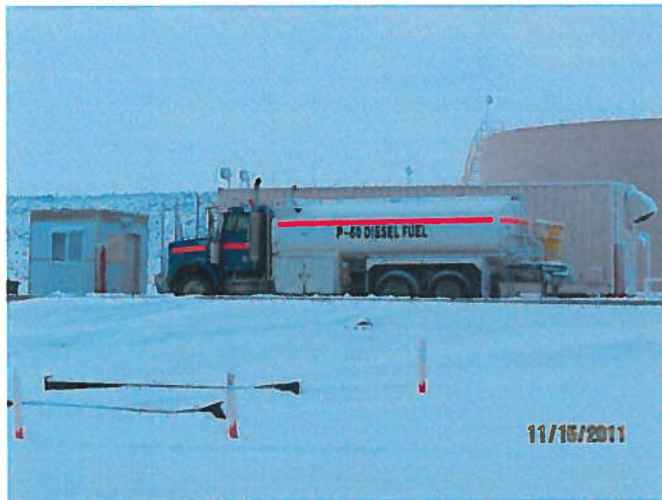
**Photo 3**

- Permanent fuel storage facilities were not yet completed. A temporary fuel transfer station has, however, been established, and this was inspected (see Photo 3). This station is on a concrete platform which should contain most drips/spills of fuel which might occur. However, secondary containment practices observed during the inspection will need to be improved. As noted in Photo 4, though spill pads were in place under the fuel-transfer area, they were not effectively secured & would most likely blow away given any sort of substantial wind event. It's also apparent that drifting snow could fill-in the secondary containment "drip" tray currently deployed at the site. Until the permanent fuel storage tanks are in place & operational, Ekati staff committed to find & implement a solution for this situation which would resolve these challenges.

Temporary fuel transfer station (Misery Camp). Note the yellow spill kit fixed to the fuel truck's back end. The site in use has a cement pad which should minimize the potential for fuel to enter the environment.

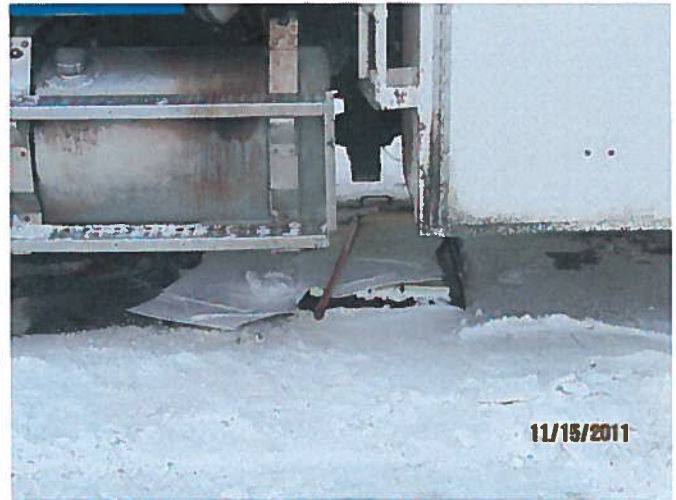
**Photo 4**

View of spill pads in use at the temporary fuel transfer station (Misery Camp). Though the pads do demonstrate effective secondary fuel containment at the time of the inspection, a more robust solution needs to be found to ensure the pads remain in place during windy conditions & don't fill in with snow.

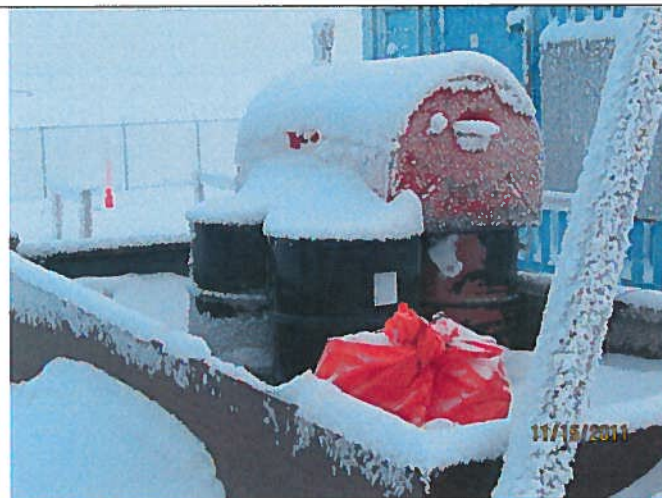
**Photo 5**

- Lubricant storage at the Misery facilities service area followed industry best practices (see Photo 5).

Temporary lubricant storage at Misery Camp. Note the secondary containment berm (lined & walled).

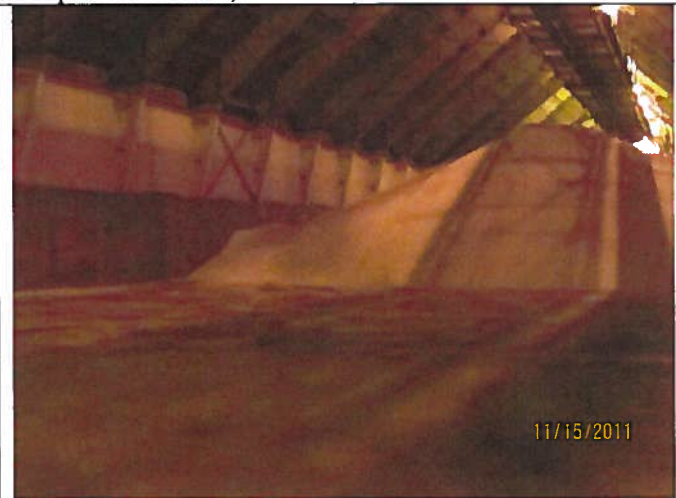
**Photo 6**

An inspection of the AN storage building showed no containment issues/concerns. AN product was effectively stored below the top of the cement walls as per industry best-practices, and no Prill was observed tracking out of the building (see Photo 6).

AN stored in the AN building was observed to remained below the top of the cement wall (which ensures no product escapes containment).
