**Re: Land Use Permit MV2009X0002  
Site Remediation  
North Inca Advanced Exploration Site Remediation, NT**

## ENVIRONMENTAL INSPECTION REPORT

Location(s) Inspected:	North Inca Advanced Exploration Site, Inca Peninsula, Indin Lake, NT
------------------------	----------------------------------------------------------------------

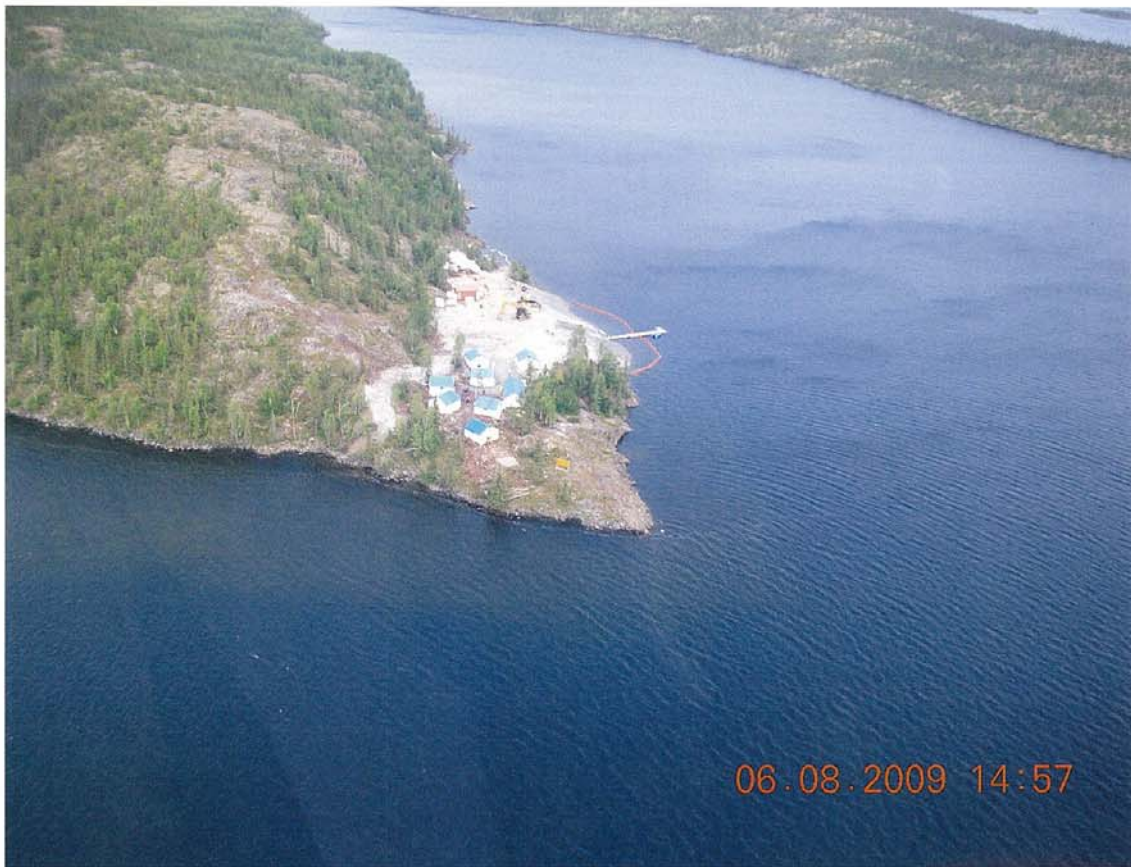
W2009X0002 - CARD - North Inca Remediation - Indin Lake, NT.  
Aerial view of the North Inca camp.

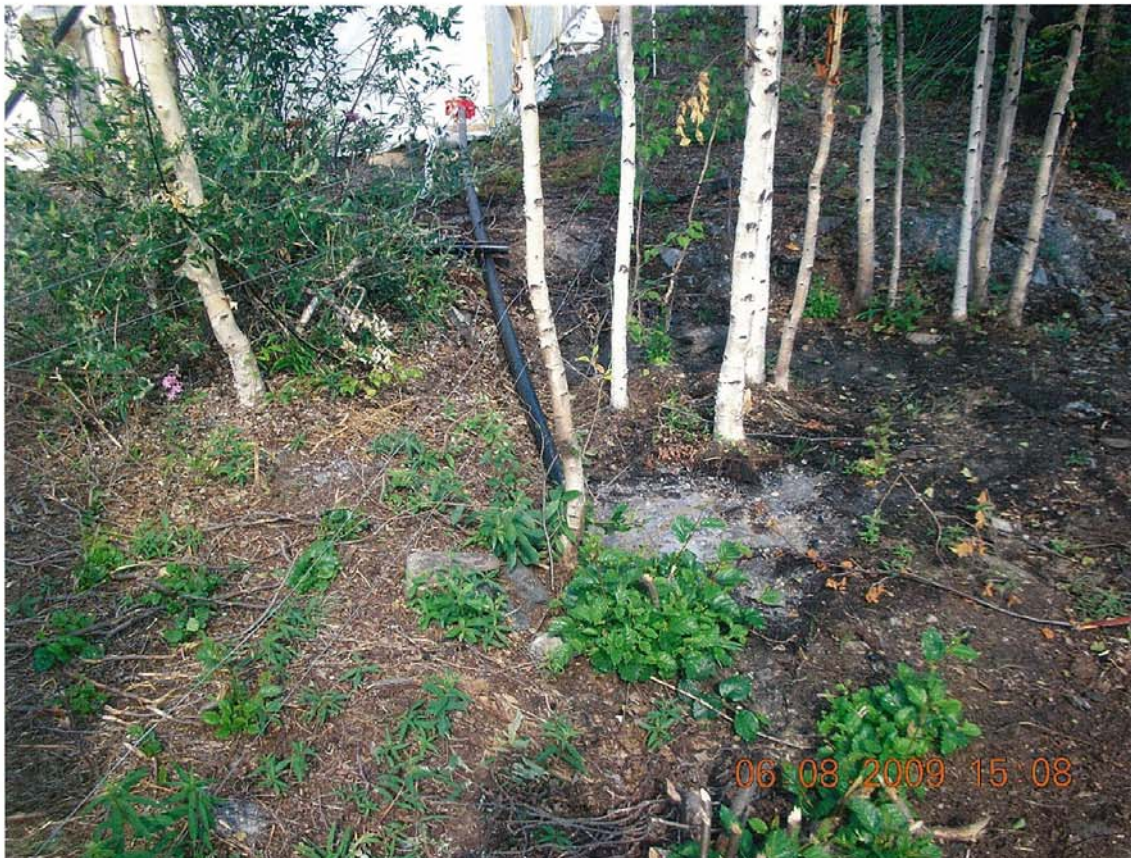
W2009X0002 - CARD - North Inca Remediation - Indin Lake, NT.  
Grey water from camp.

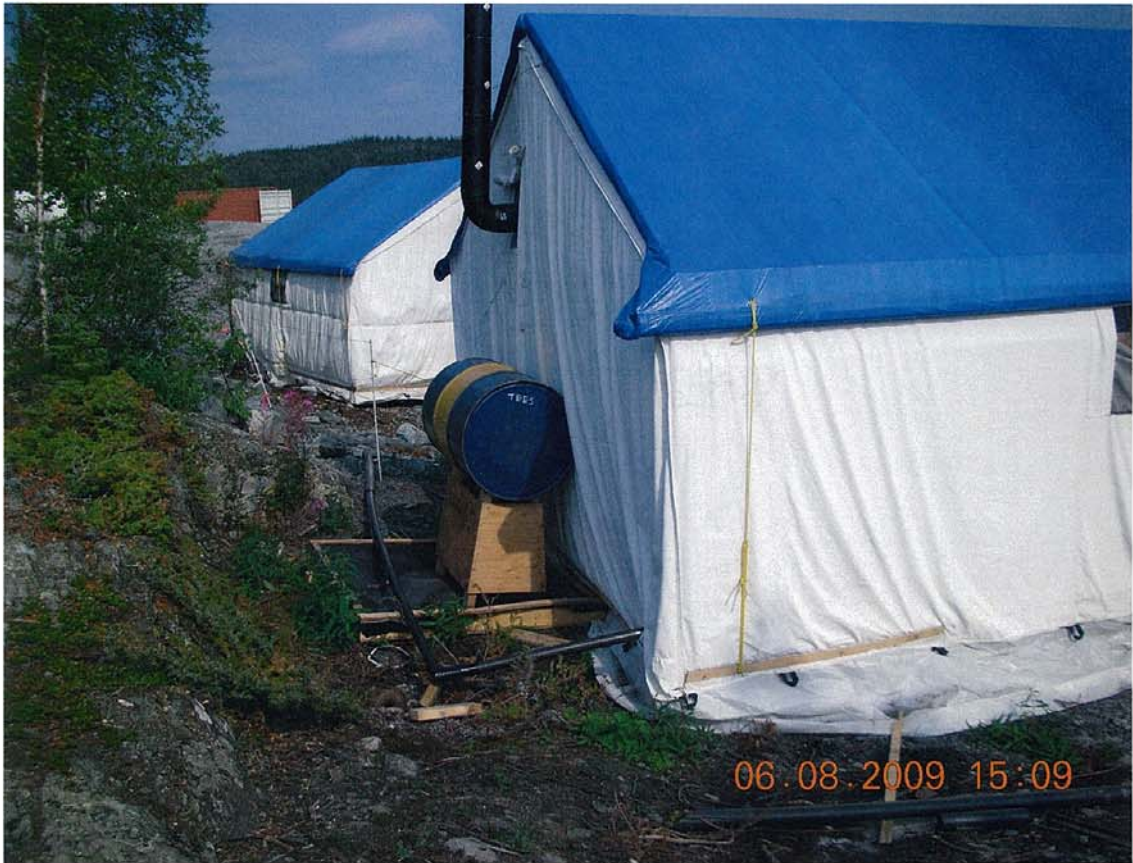
No concerns were noted during the course of the inspection. Camp was being well maintained. All active drums for the tents on site were stored within secondary containment and the fittings wrapped to contain any leaks or spills that may occur. Fuel on site was stored within 3 2500L envirotanks. The generator was also positioned within a secondary containment structure to prevent migration of hydrocarbons to surrounding lands in the event of a spill.

W2009X0002 - CARD - North Inca Remediation - Indin Lake, NT.  
All active drums have fittings wrapped with absorbents and are stored within secondary containment structures.

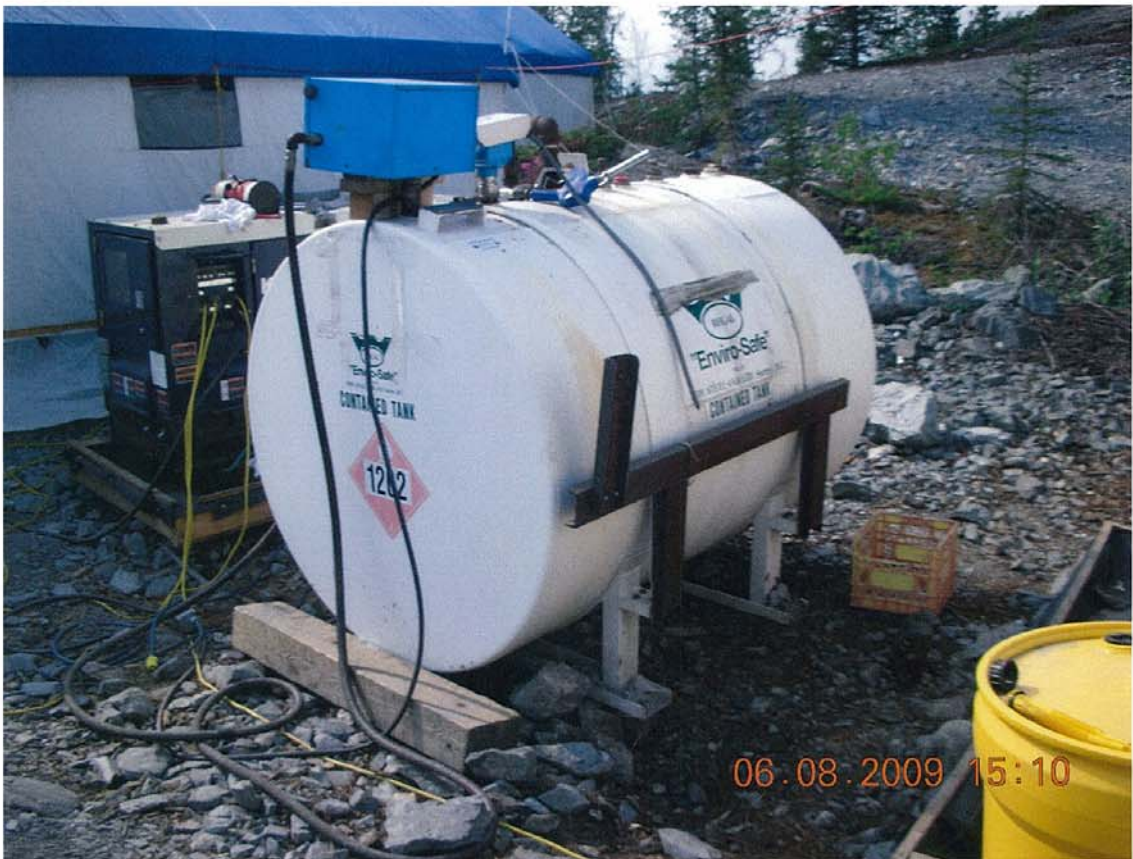
W2009X0002 - CARD - North Inca Remediation - Indin Lake, NT.  
Fuel storage within a 2500L enviro-tank and generator within secondary containment.

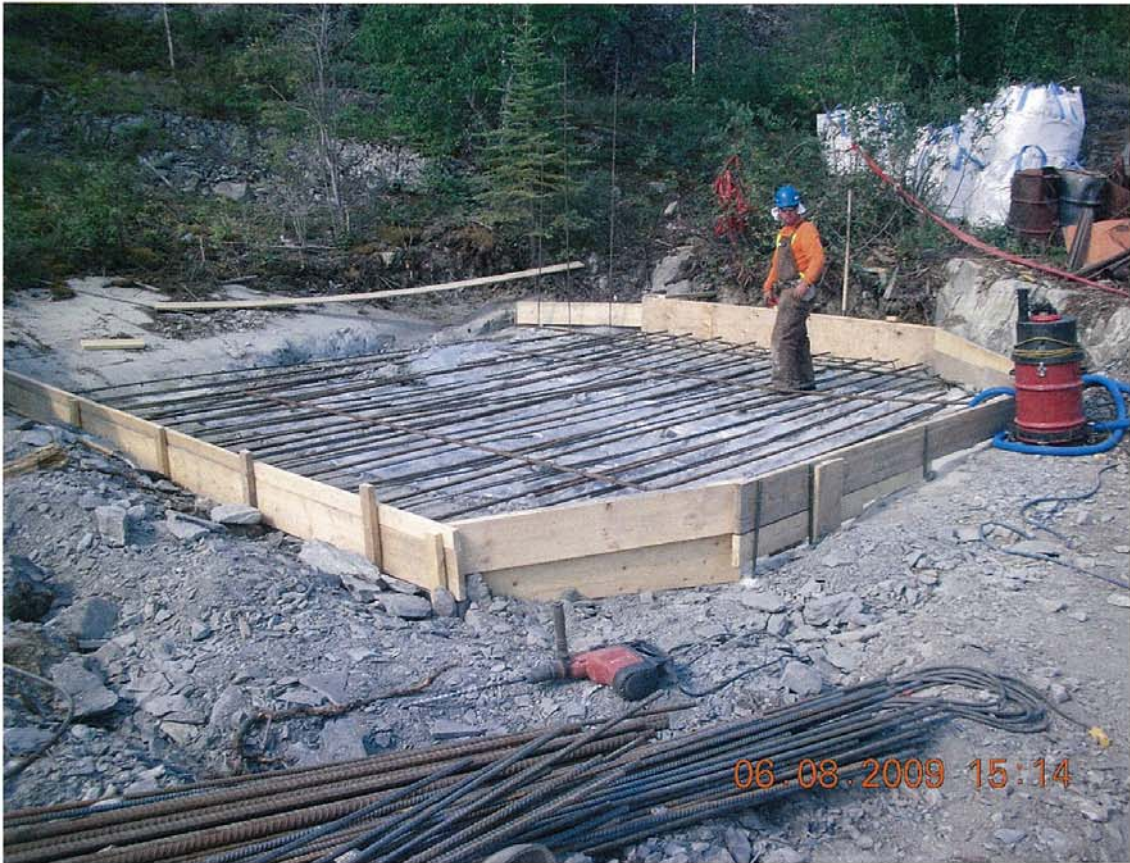
The form for the portal plug was being constructed during the inspection and concrete to complete the job was expected on site the following day. Once the concrete arrives on site the portal plug will be completed and the summer program will come to an end.

W2009X0002 - CARD - North Inca Remediation - Indin Lake, NT.  
Portal is being prepared for the installation of a concrete plug.

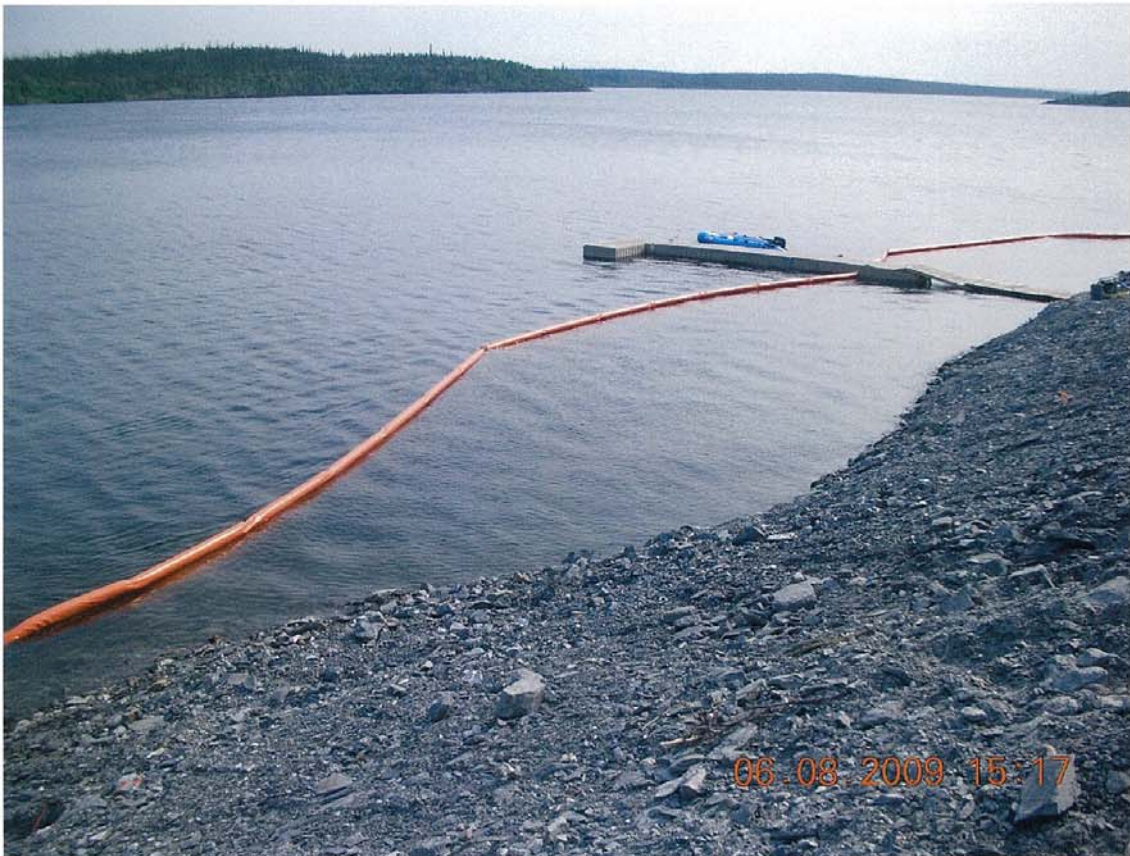
W2009X0002 - CARD - North Inca Remediation - Indin Lake, NT.  
Silt curtain deployed in Indin Lake prior to resloping the bank adjacent camp.

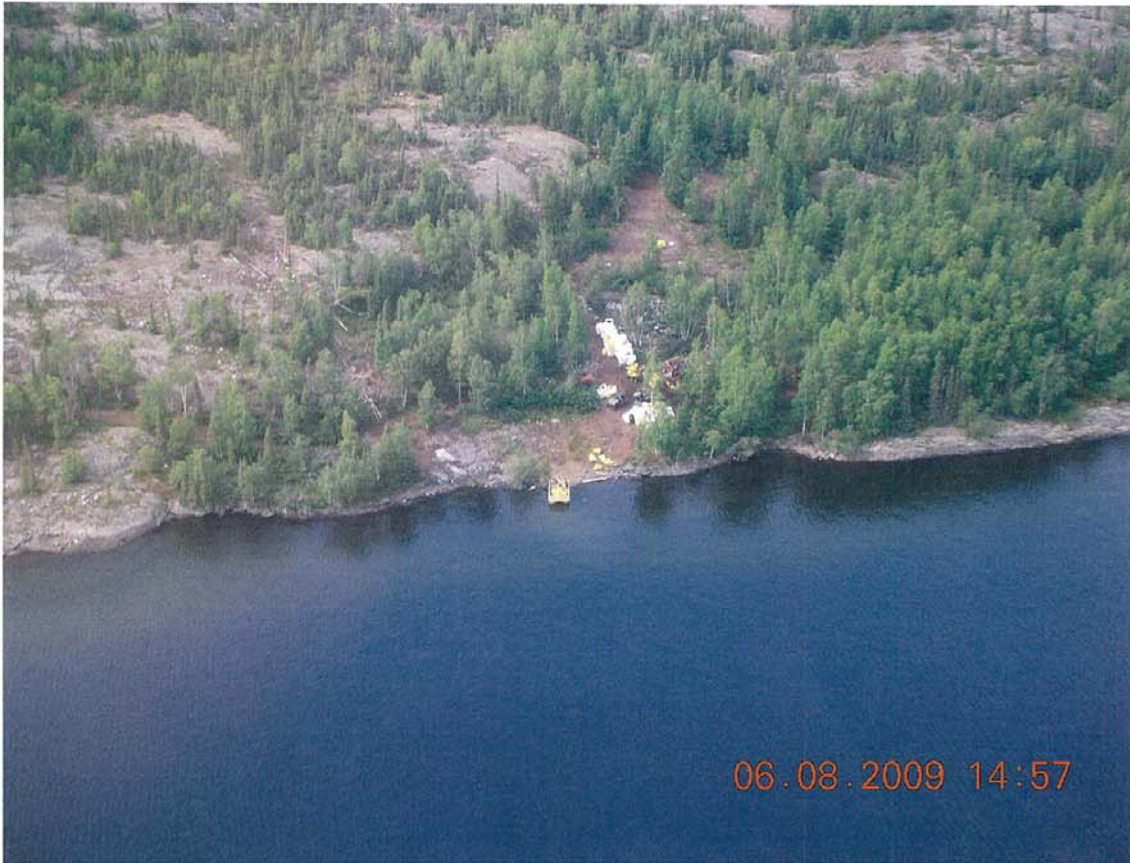
W2009X0002 - CARD - North Inca Remediaton - Indin Lake, NT.  
Waste items are being collected and stored near the shores of Indin Lake for winter transport to Colomac for disposal.

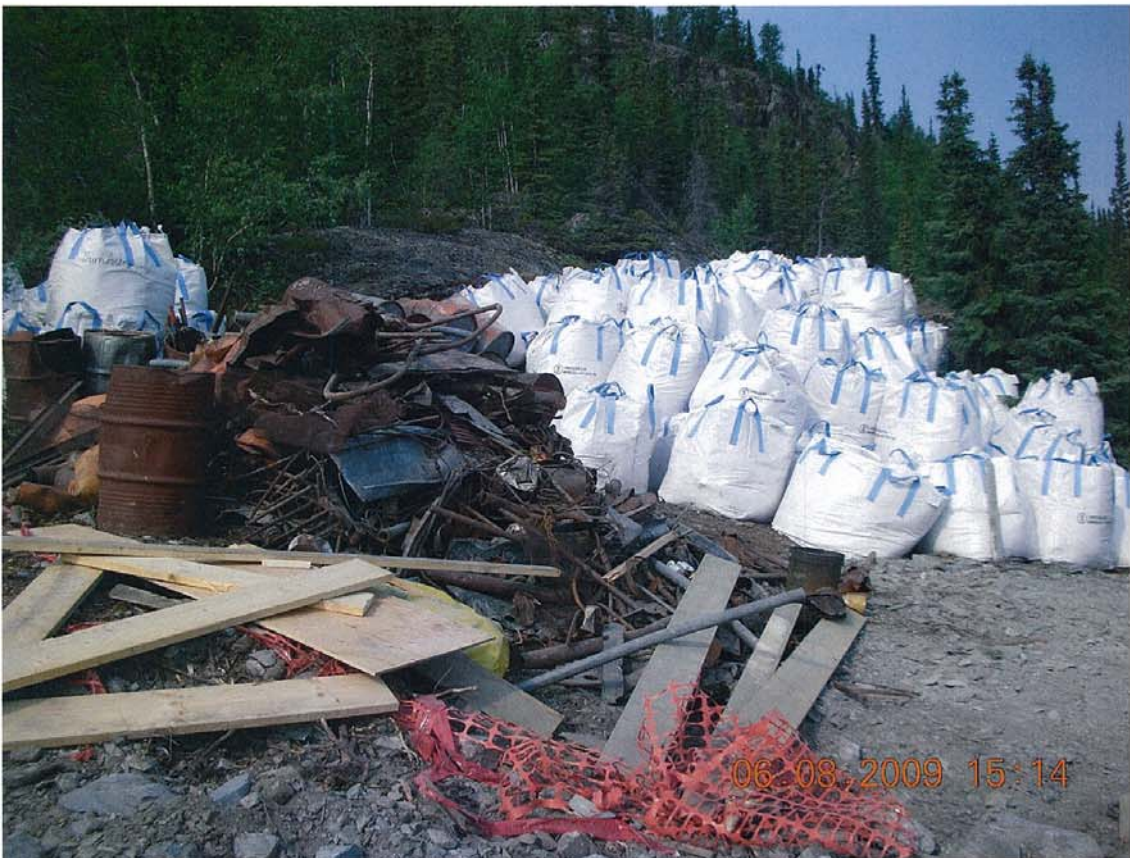
Several nylon bags were staged adjacent the camp. The majority of the bags contain hydrocarbon contaminated soils that will be transported to Colomac via winter road and will be treated at the land farming facility there. Some of the bags contain waste metals and glass that will be deposited in the Colomac landfill.

W2009X0002 - CARD - North Inca Remediaton - Indin Lake, NT.  
Waste metals and contaminated soils stored for back haul to Colomac for disposal in the landfill and landfarm.
