#16 Yellowknife Airport
Yellowknife, NWT
X1A 3T2

September 22nd, 2010

**Re: Land Use Permits W2009X0007 and W2009X0002
 Site Remediation
 Colomac Mine Site and North Inca Advanced Exploration Site Remediation, NT**

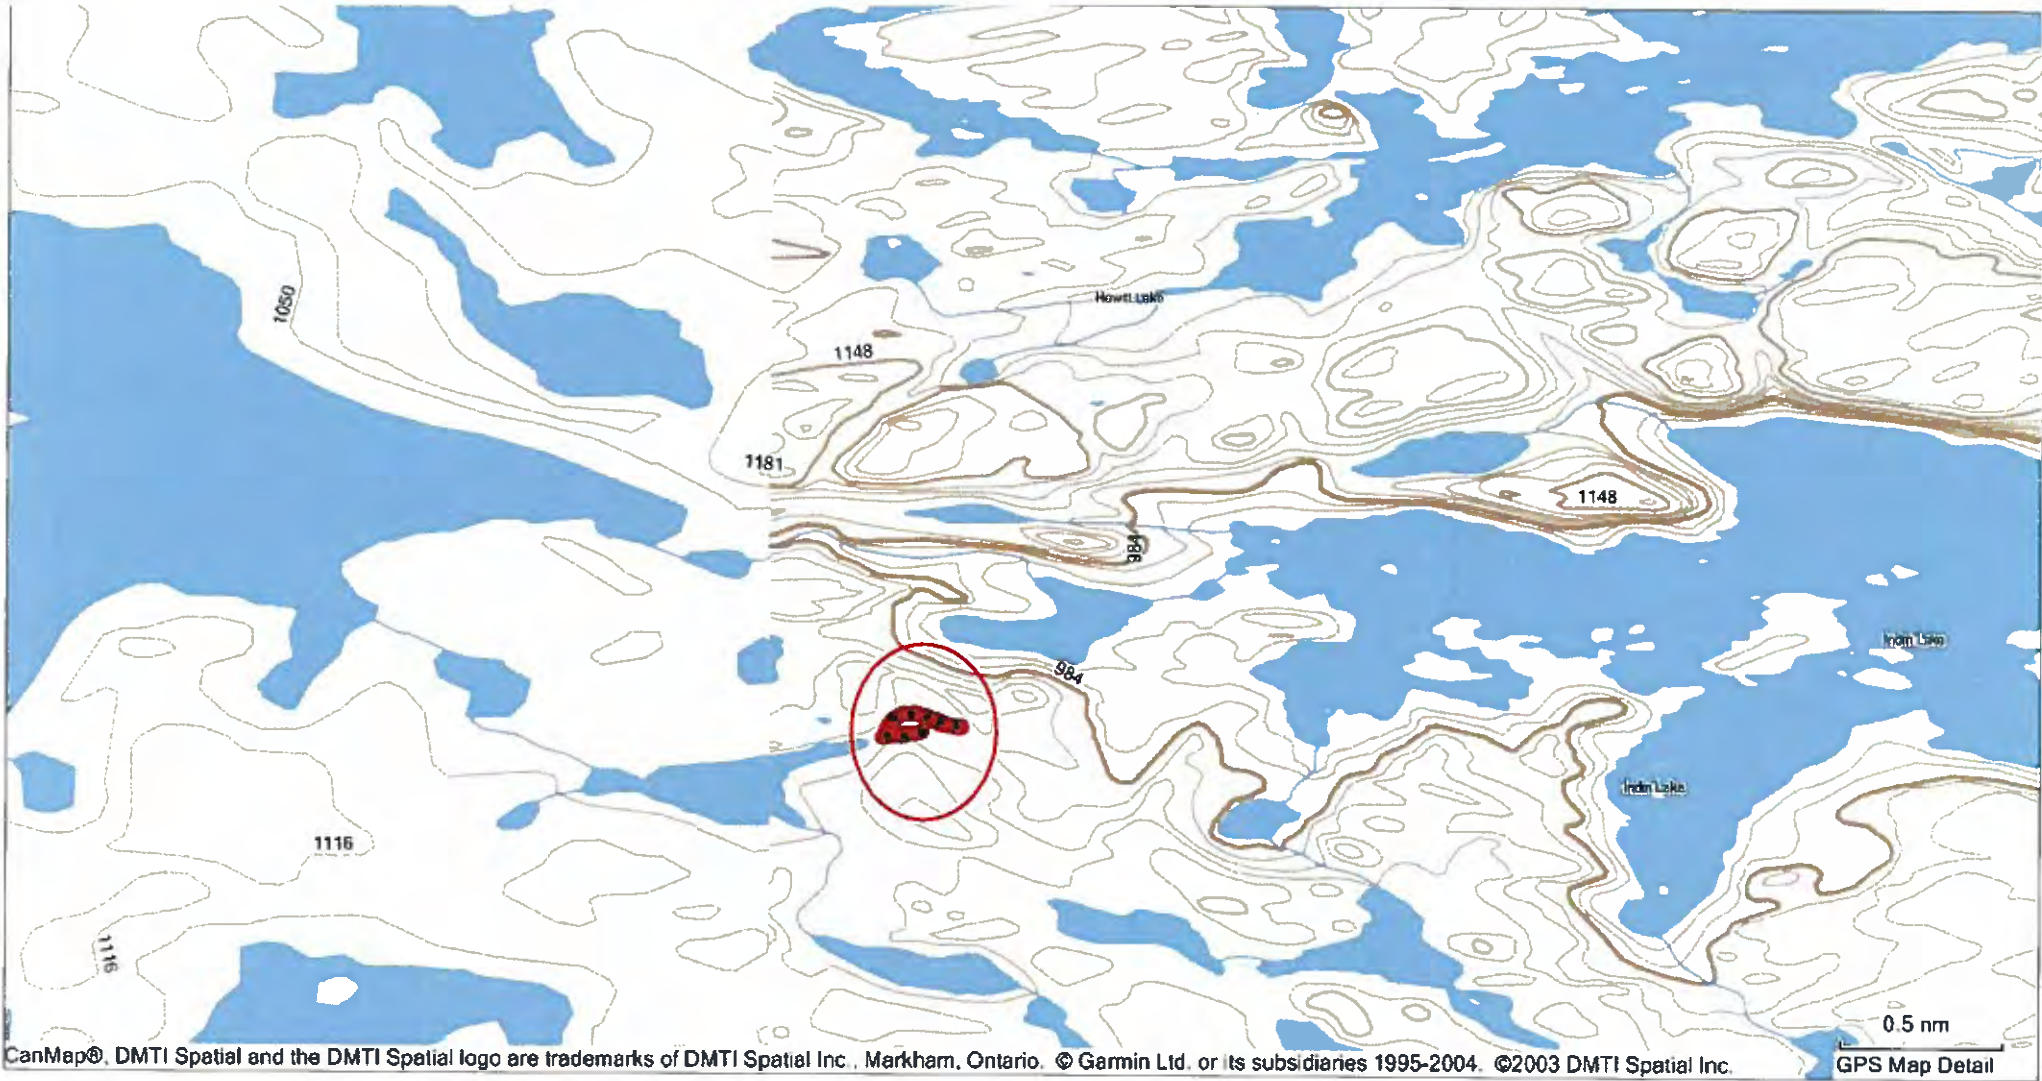
Existing and proposed bypass are circled.

The Inspector does not foresee any major concerns with the proposed route re-alignment as it is approximately 600 feet in length and through an area that is sparsely treed for the most part. Prior to any work being conducted on this new route, the Permittee must ensure that this proposed route will be conducive to use by heavy haul trucks, improve the line of sight along this section of portage, and ultimately reduce the likelihood of an accident or rollover from occurring, which is the concern at the existing section of the portage.

Since the re-routing is within the boundaries of the Tli Cho land claim, prior to any work being undertaken, the Permittee must consult with the Tli Cho Community Government of Wekweëti and the Tli Cho Lands Protection Department. All correspondence received from these two organizations must be provided to the Inspector and WLWB.

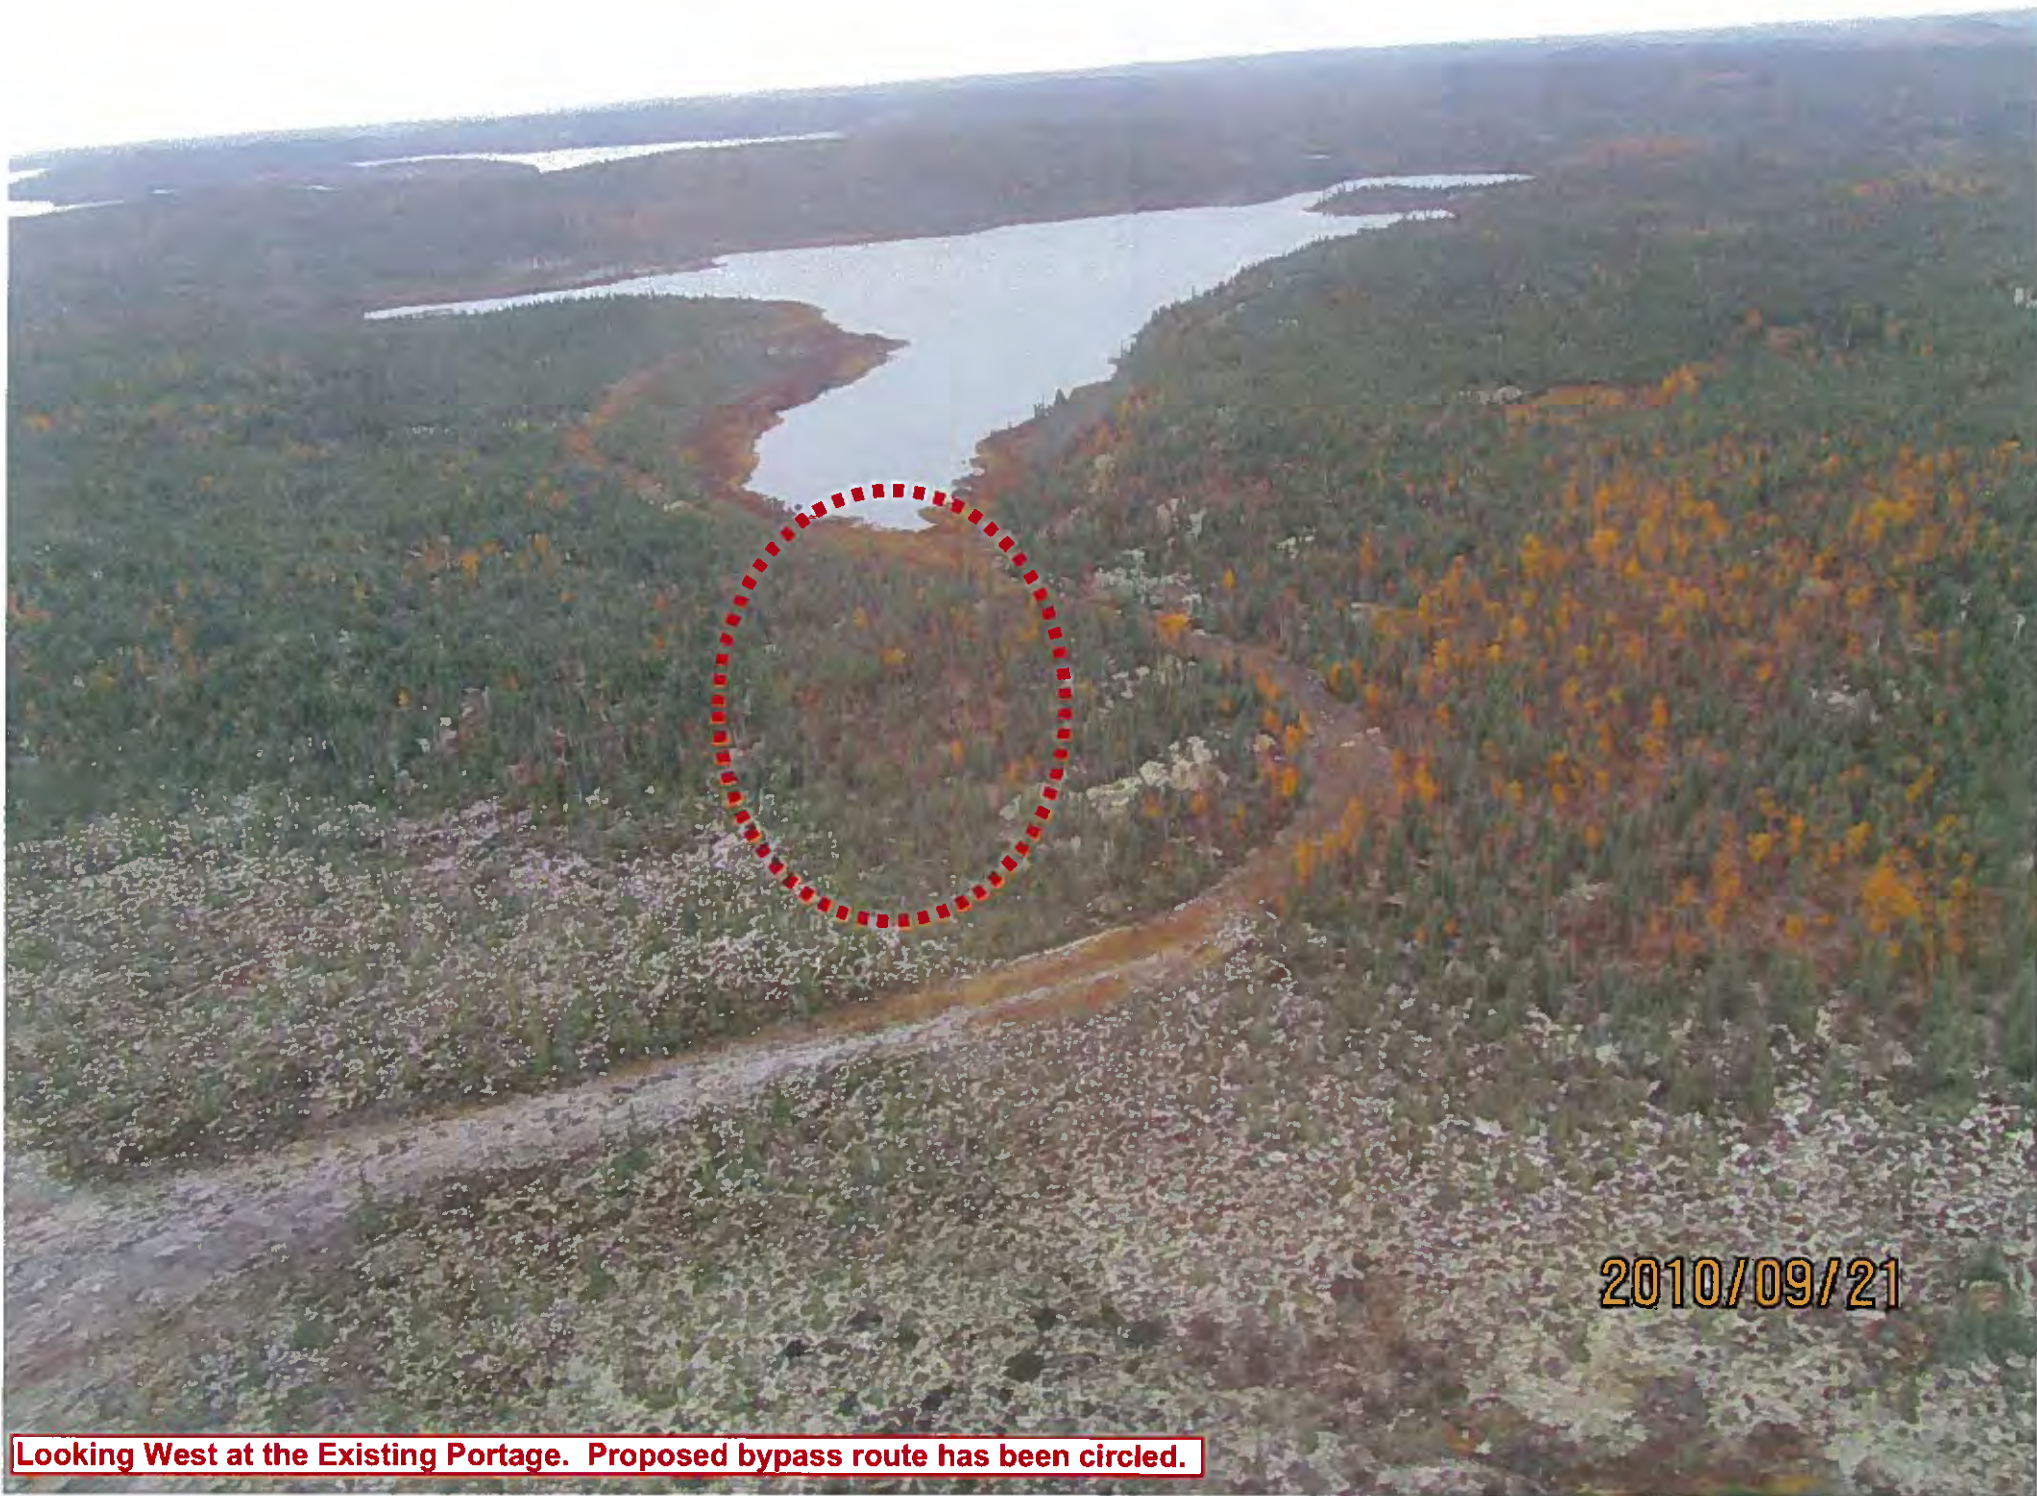
Looking West at the Existing Portage. Proposed bypass route has been circled.

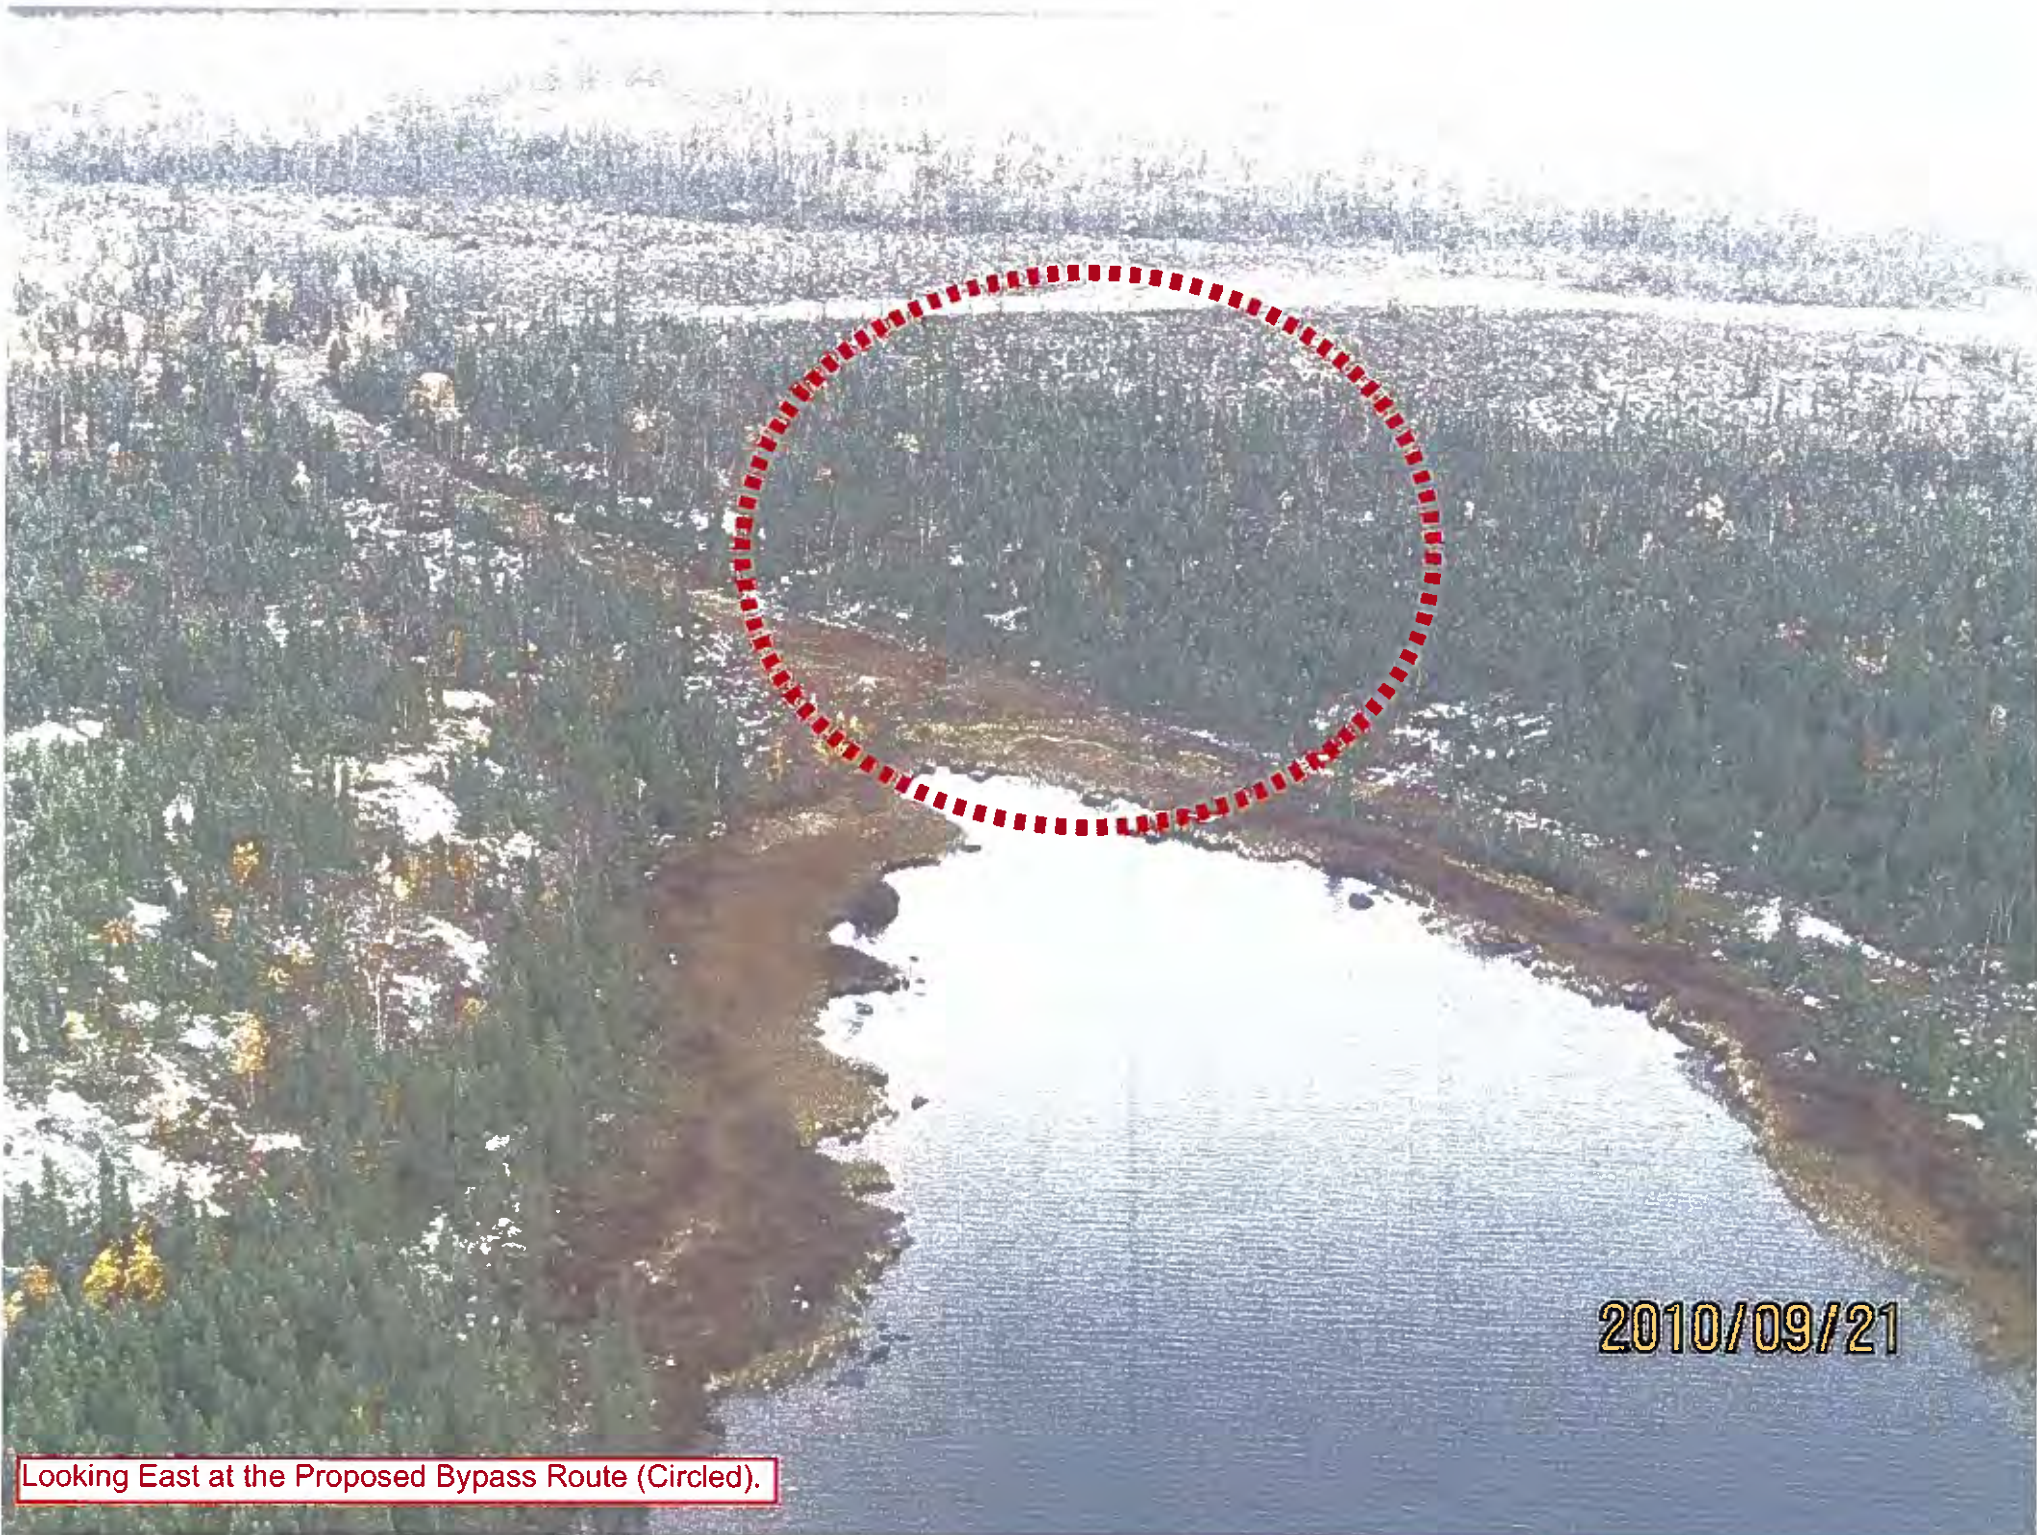
Looking East at the Proposed Bypass Route (Circled).

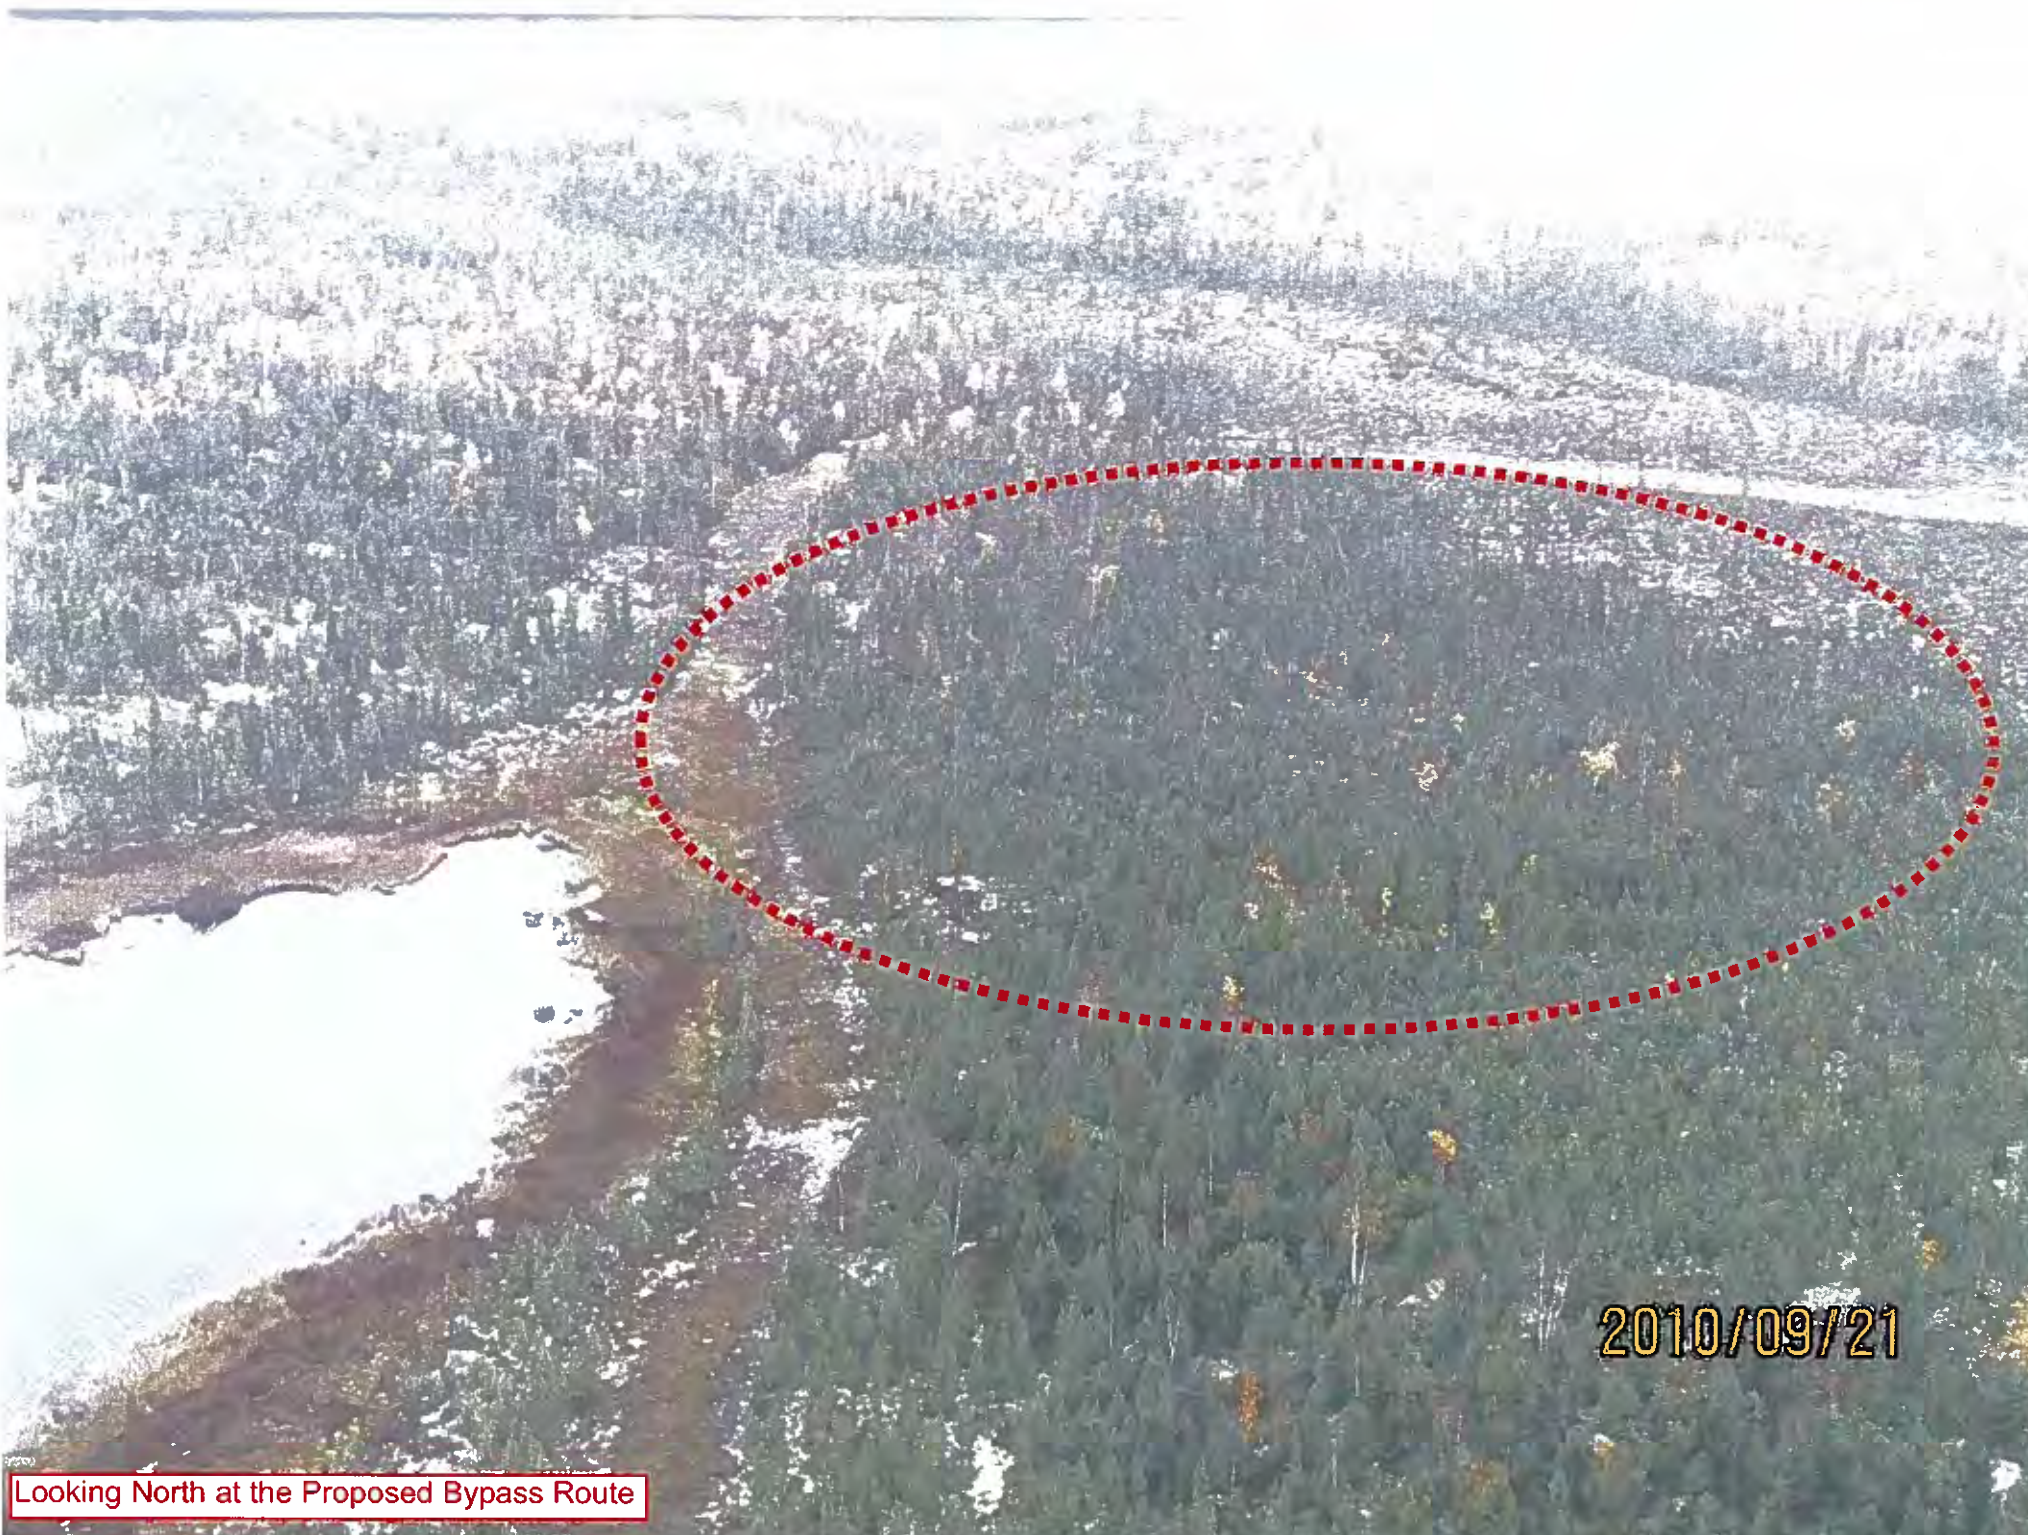
Looking North at the Proposed Bypass Route

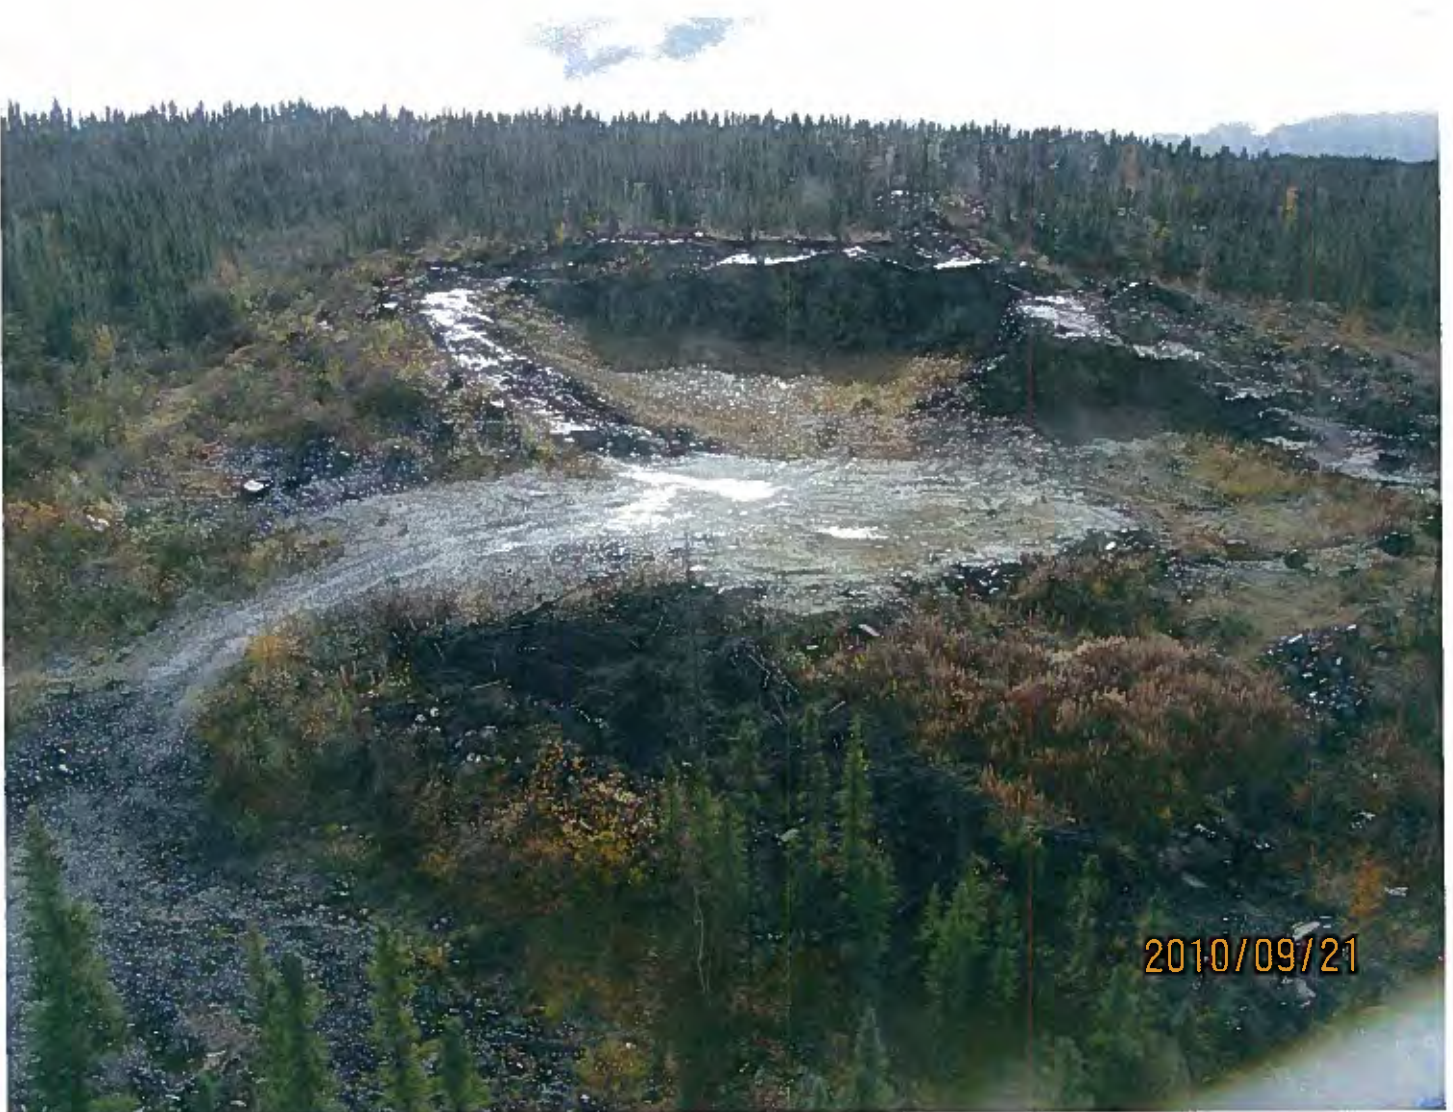
- The brush/tree piles noted in the Spruce Lake Quarry remain, and they require proper disposal as per the operating conditions annexed to the land use permit or as approved in writing by the Inspector.
- Oversize rock was noted on the floor of the Pilot Plant Quarry (south of Tailings Lake) and this material must be tucked up against the working face to meet the reclamation guidelines for pits and quarries.
- Windrows of trees and brush were noted along the trail (diversion ditches) west of tailings lake that require proper disposal as per the operating conditions annexed to the land use permit or as approved in writing by the Inspector.

W2009X0007 - Colomac Mine Site - INAC-CARD
Spruce lake quarry and brush piles still remain that require disposal and are viewed in the foreground of the photo.

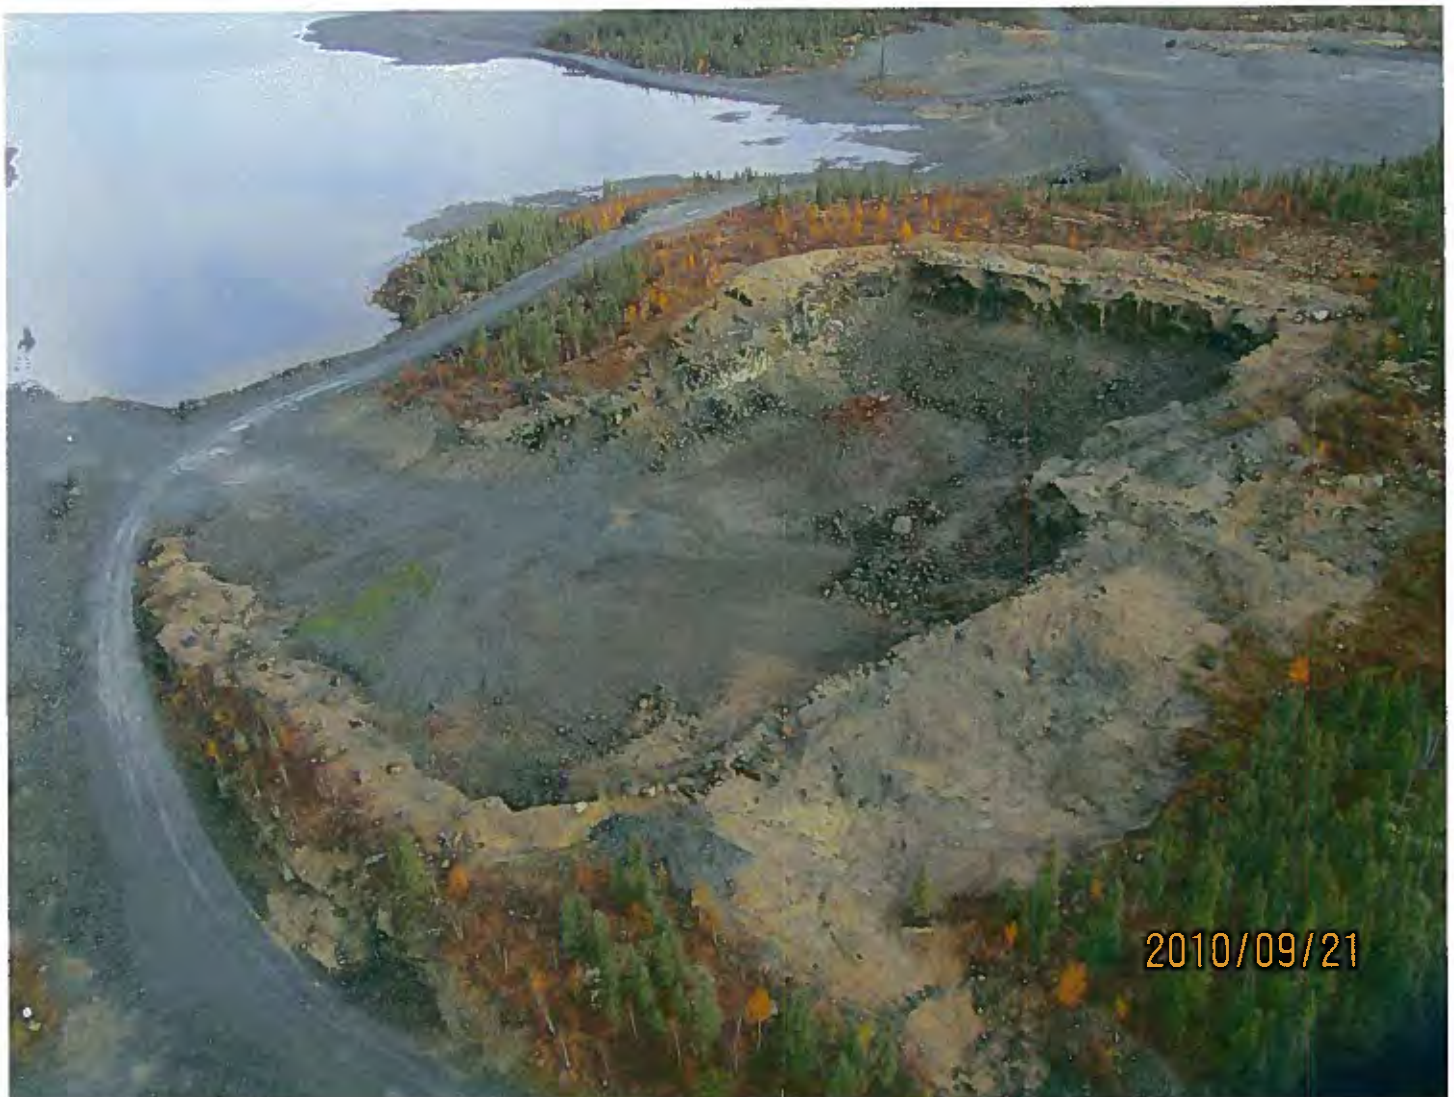
W2009X0007 - Colomac Mine Site - INAC-CARD
Tailing quarry and oversized rock in the centre of the quarry must be tucked up against the working face.

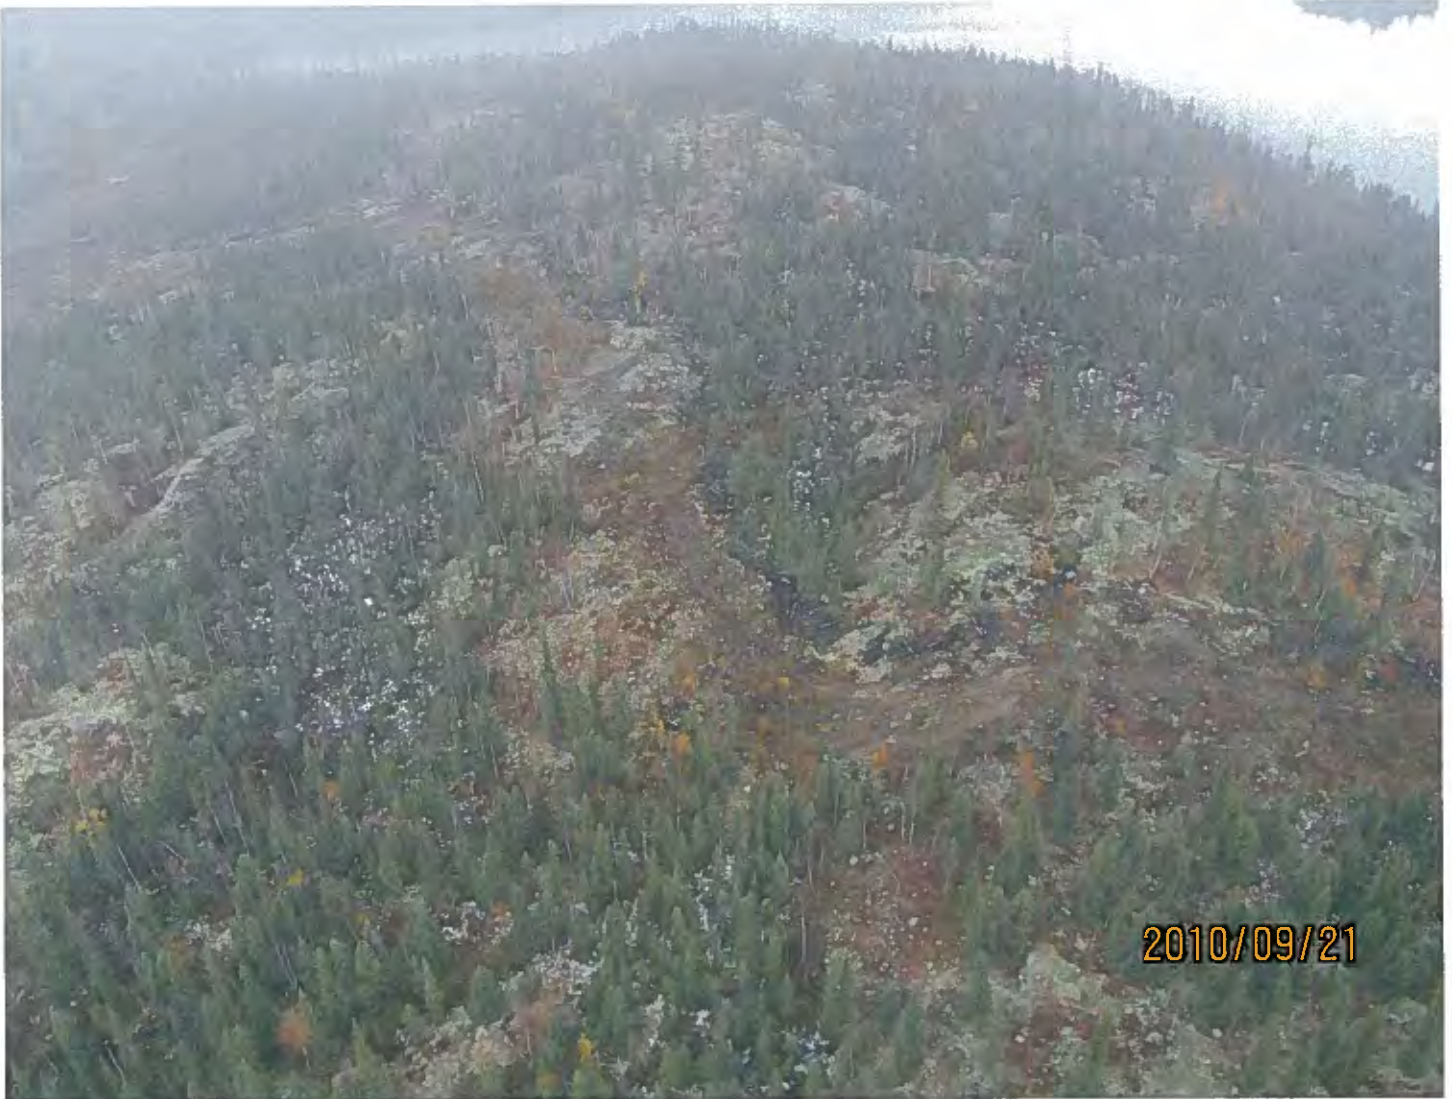
W2009X0007 - Colomac Mine Site - INAC-CARD

Trail on the west side of tailings lake. Windrows of trees were noted along its entire length that require proper disposal.

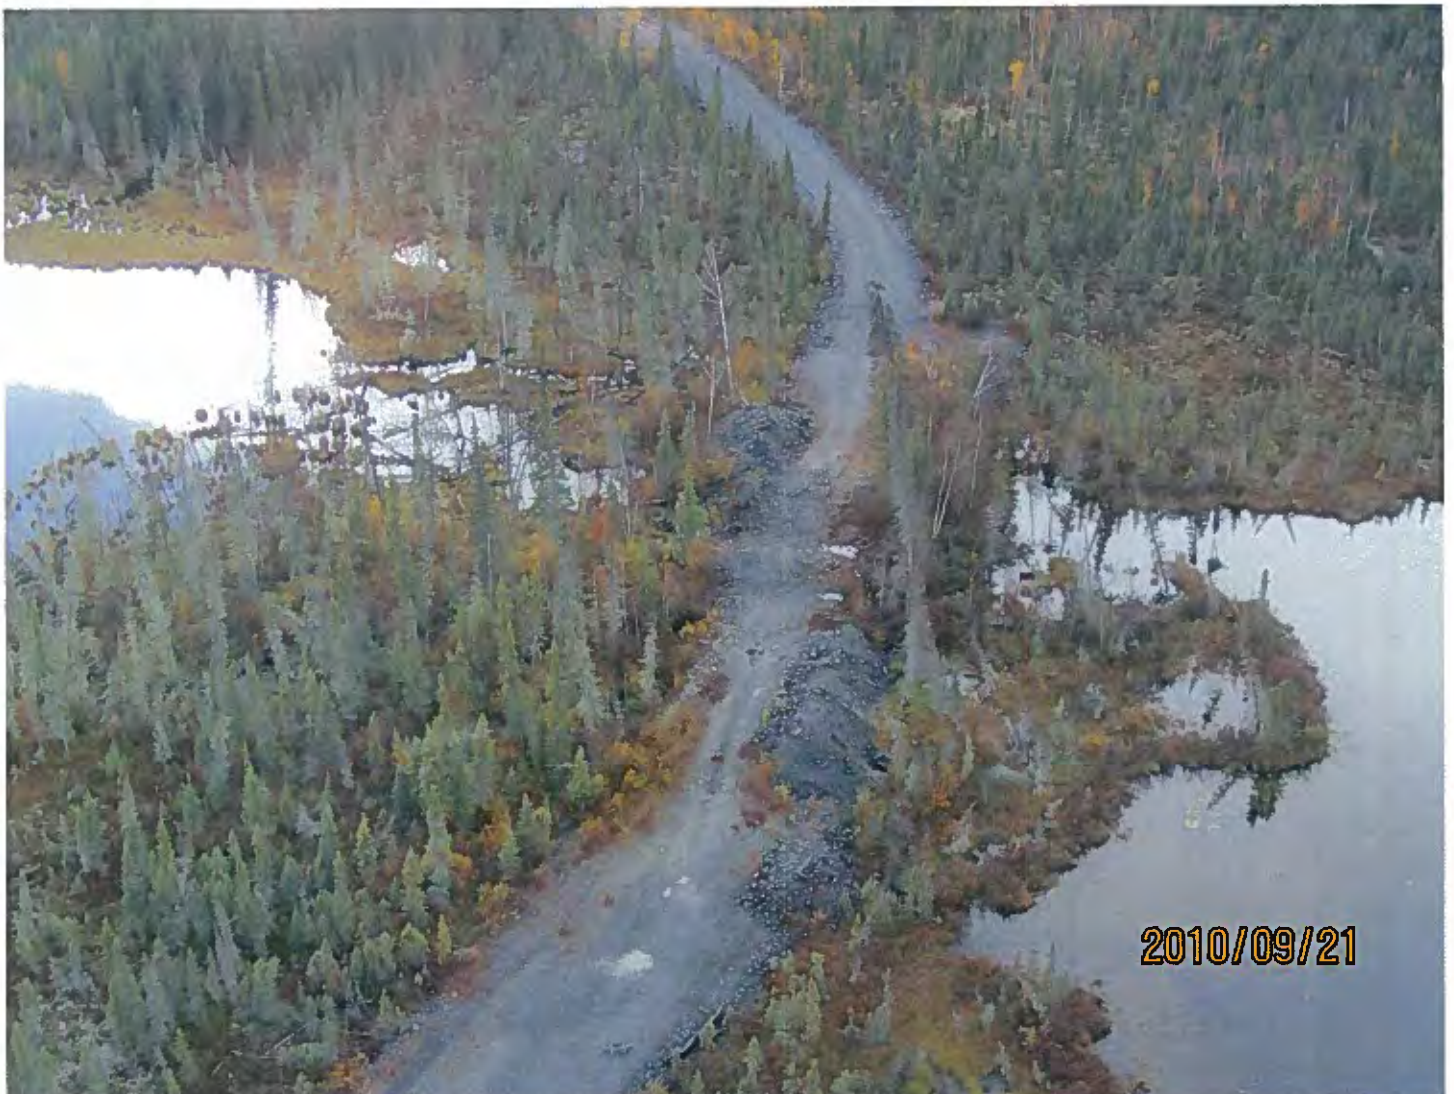
The first creek crossing on this road as you travel south from the Colomac Mine Site was inspected and the Inspector was unclear of the Permittee's requirements for the re-establishment of drainage at this location. Water was not actively flowing and piles of rock were noted on either side of the creek. This area should be re-visited by the Permittee to ensure natural drainage is re-established and final reclamation objectives for roads in the land use area are met.

W2009X0007 - Colomac Mine Site - INAC-CARD - First stream crossing on the Kim Cass Road. Piles of rock should be re-contoured and re-establishment of drainage confirmed by the Permittee.

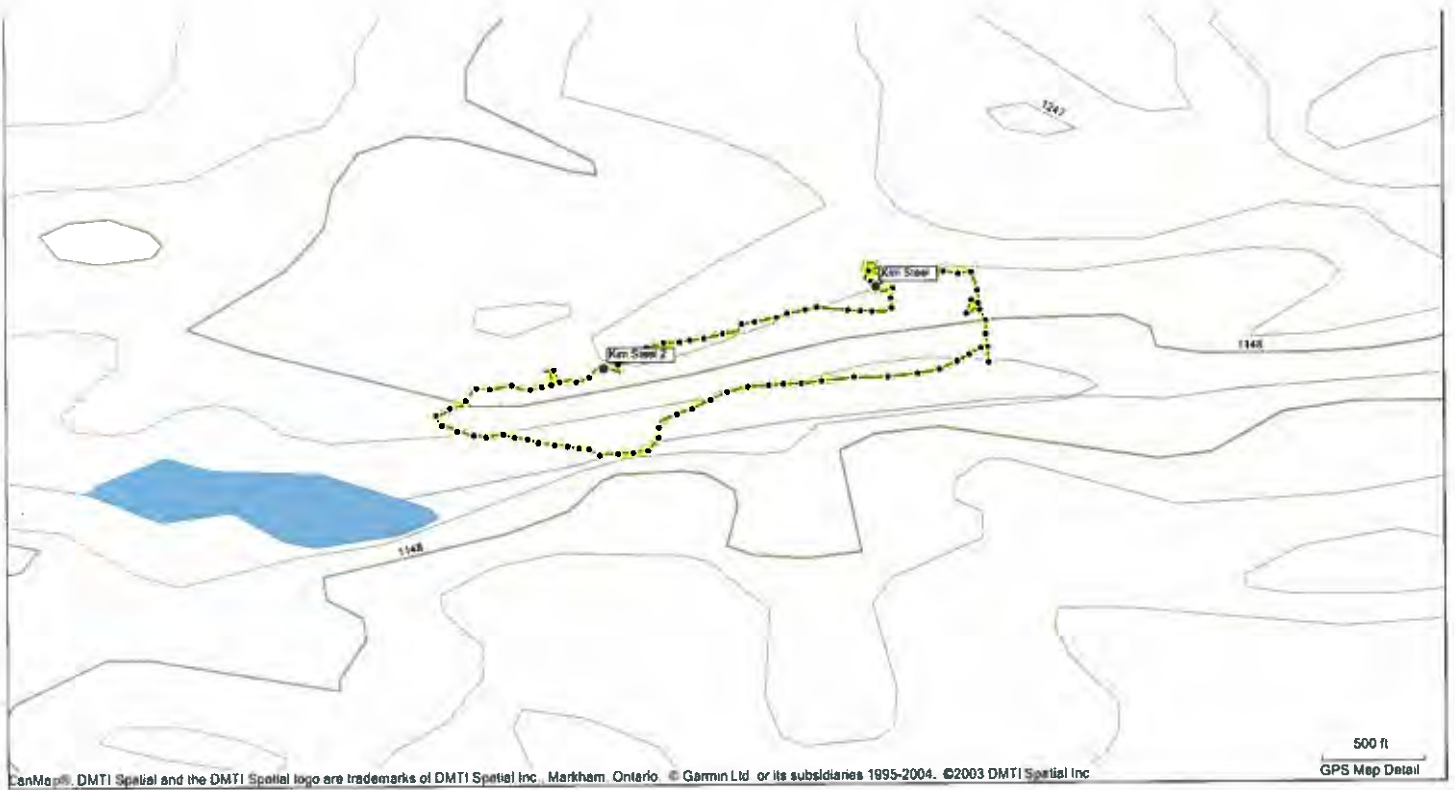
The perimeter of the bulk sample location east of Hewitt Lake was inspected and only three drill holes were observed that were not sealed. The location of these sites is depicted on the attached map and if the Permittee requires the waypoints, the undersigned Inspector can provide them.

W2009X0007 - Colomac - INAC-CARD
 Map displaying bulk sample perimeter (Kim Cass) and 2 locations where drill steel and open holes were noted.

At these two locations, lengths of drill steel were observed, and if the Permittee is returning to this portion of the land use area to address the unsealed drill holes, they must be removed for proper disposal at an approved disposal facility. Also, if any other garbage or debris is observed it must be removed for proper disposal.

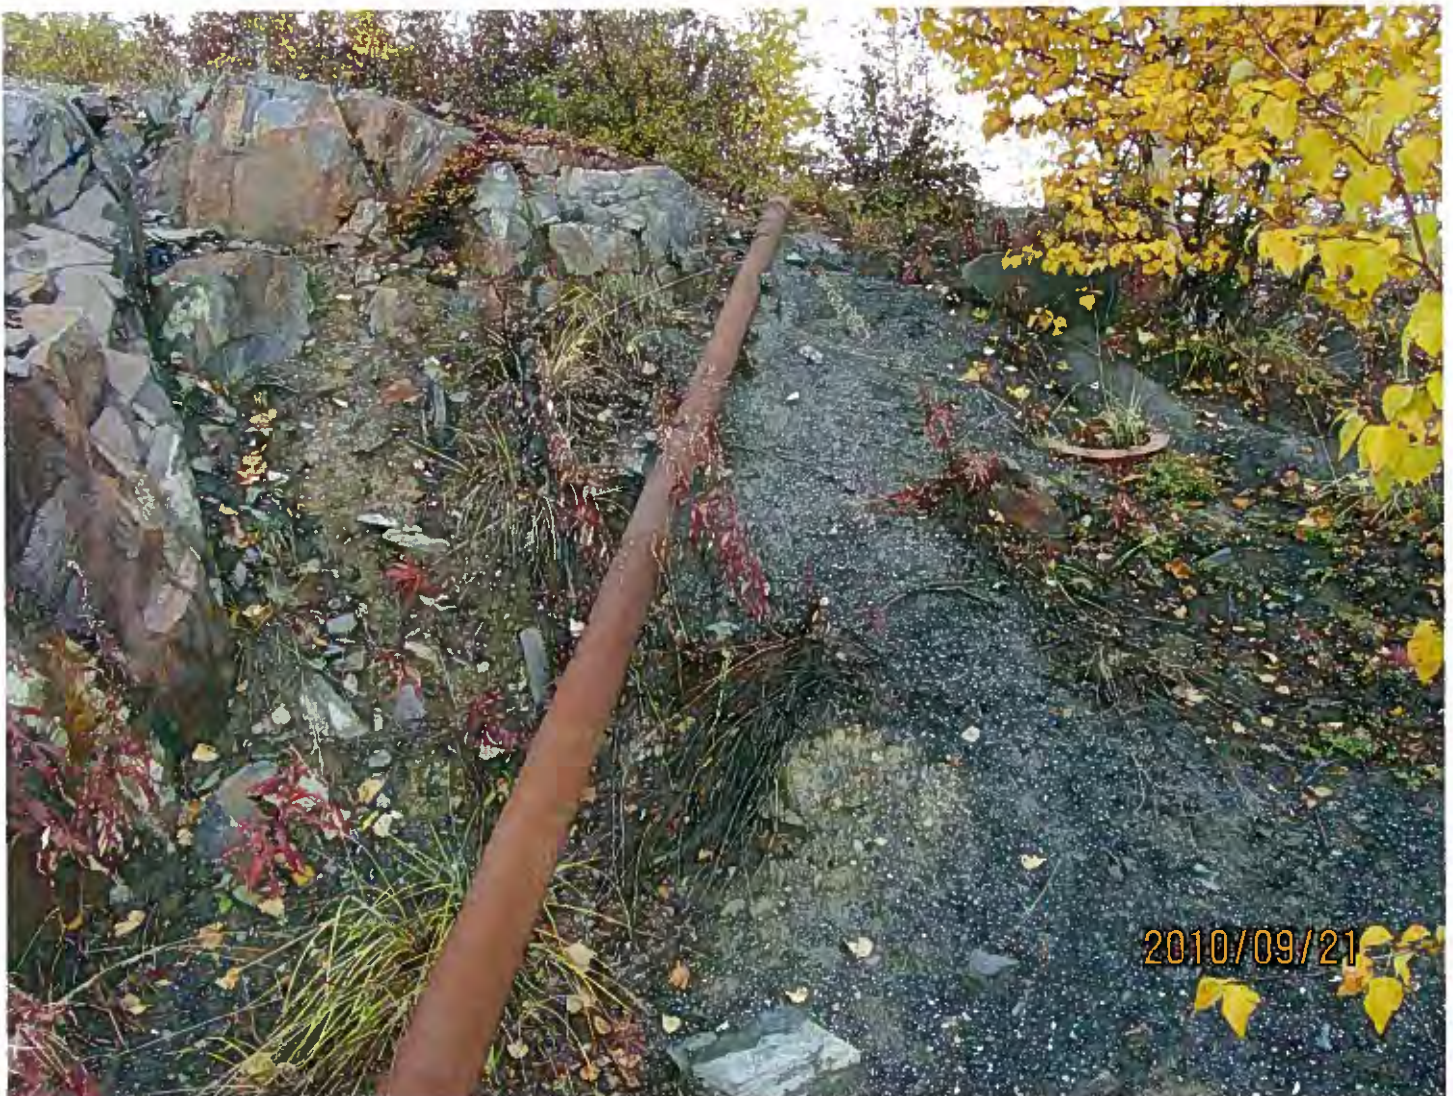
W2009X0007 - Colomac Mine Site - INAC-CARD
 One of three open drill holes (red cone to the right of the photo) and piece of casing.
