#16 Yellowknife Airport
Yellowknife, NWT
X1A 3T2

September 22nd, 2010

**Re: Land Use Permits W2009X0007 and W2009X0002
 Site Remediation
 Colomac Mine Site and North Inca Advanced Exploration Site Remediation, NT**

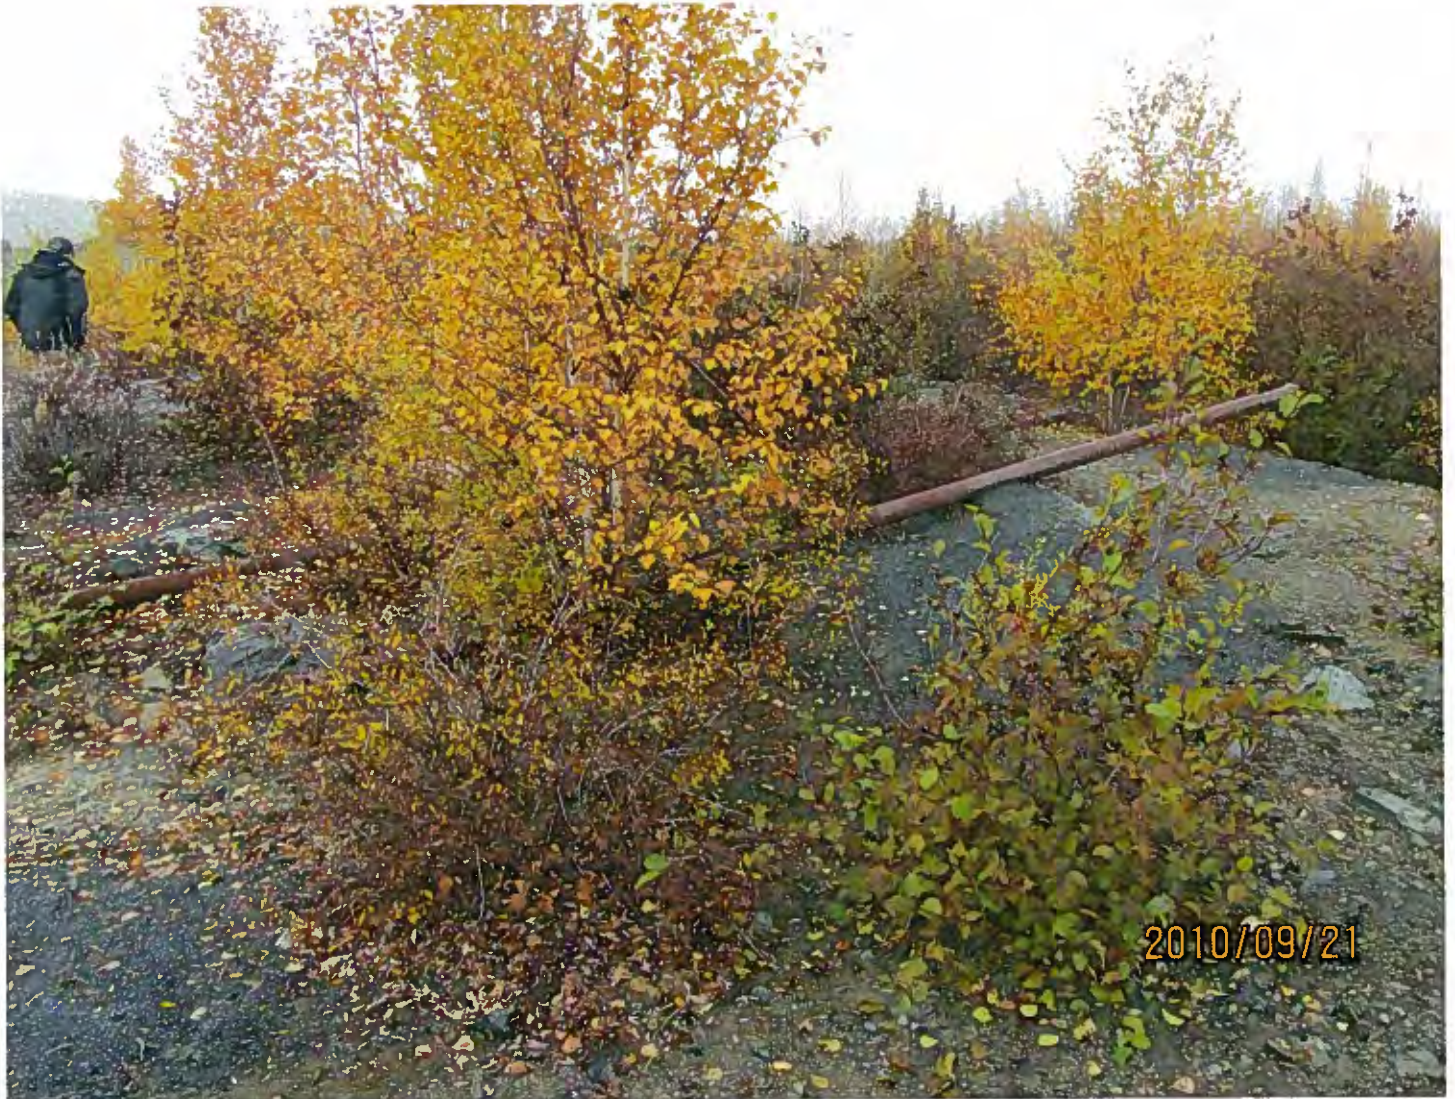
W2009X0007 - Colomac Mine Site - INAC-CARD

Another area at the bulk sample site on the Kim Cass Road where casing was present with the other two open drill holes.

At these two locations, lengths of drill steel were observed, and if the Permittee is returning to this portion of the land use area to address the unsealed drill holes, they must be removed for proper disposal at an approved disposal facility. Also, if any other garbage or debris is observed it must be removed for proper disposal.

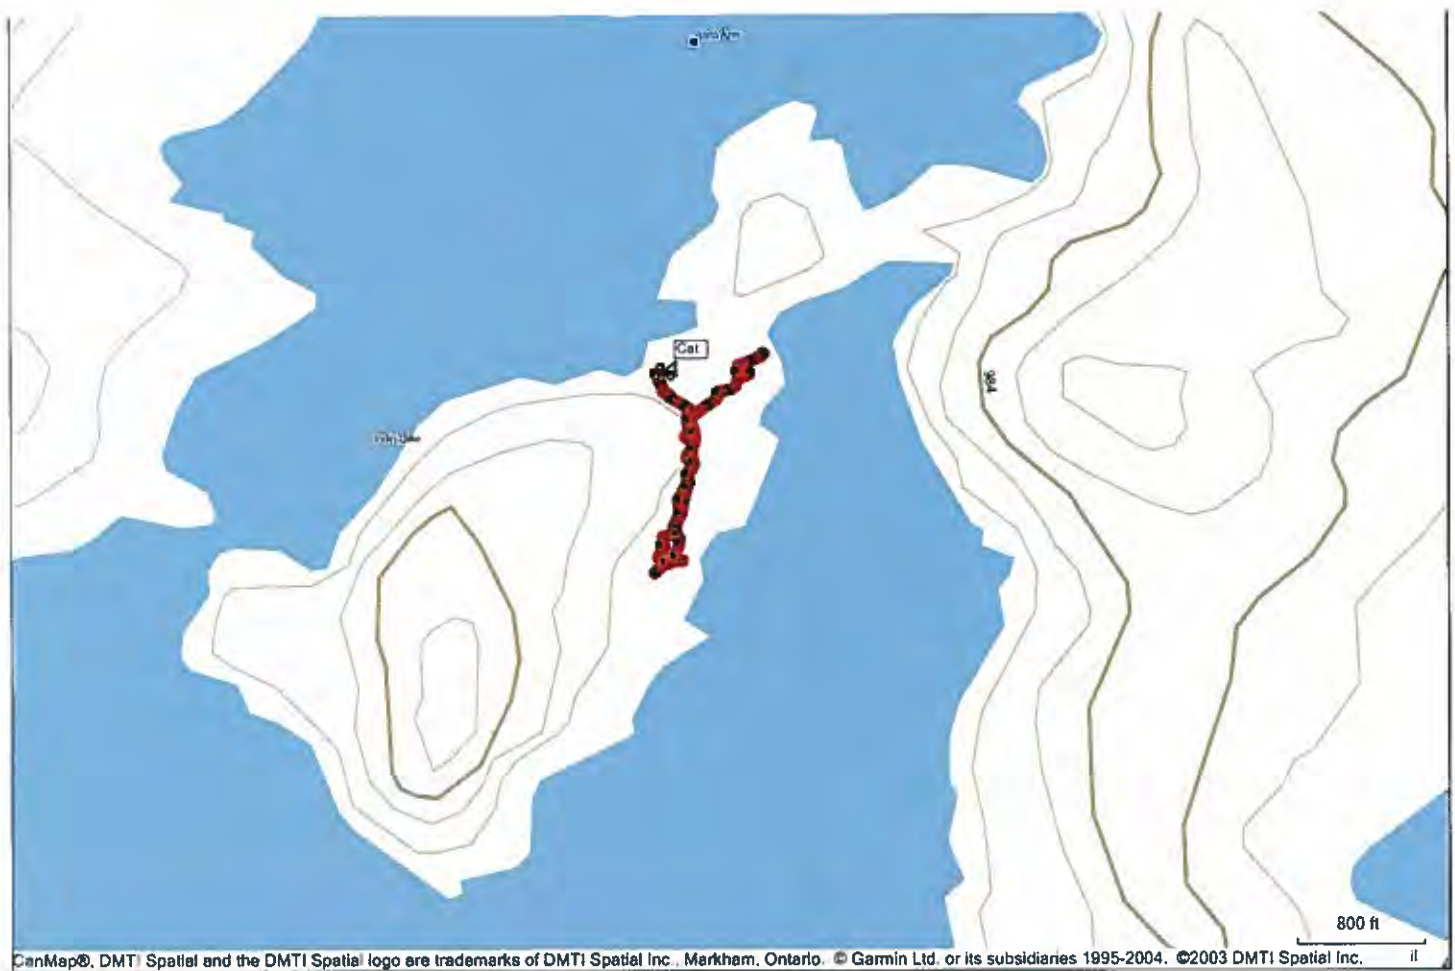
W2009X0002 - North Inca - INAC-CARD

Map displaying cat location and two potential existing trails that can be utilized to remove the cat.

The removal of the inoperable Cat at the north end of the land use area was discussed. As seen in the attached map, there are a couple of existing trails which will be conducive to its removal, and therefore this activity falls within the scope of the land use permit and is permitted by the Inspector to occur this winter road season.

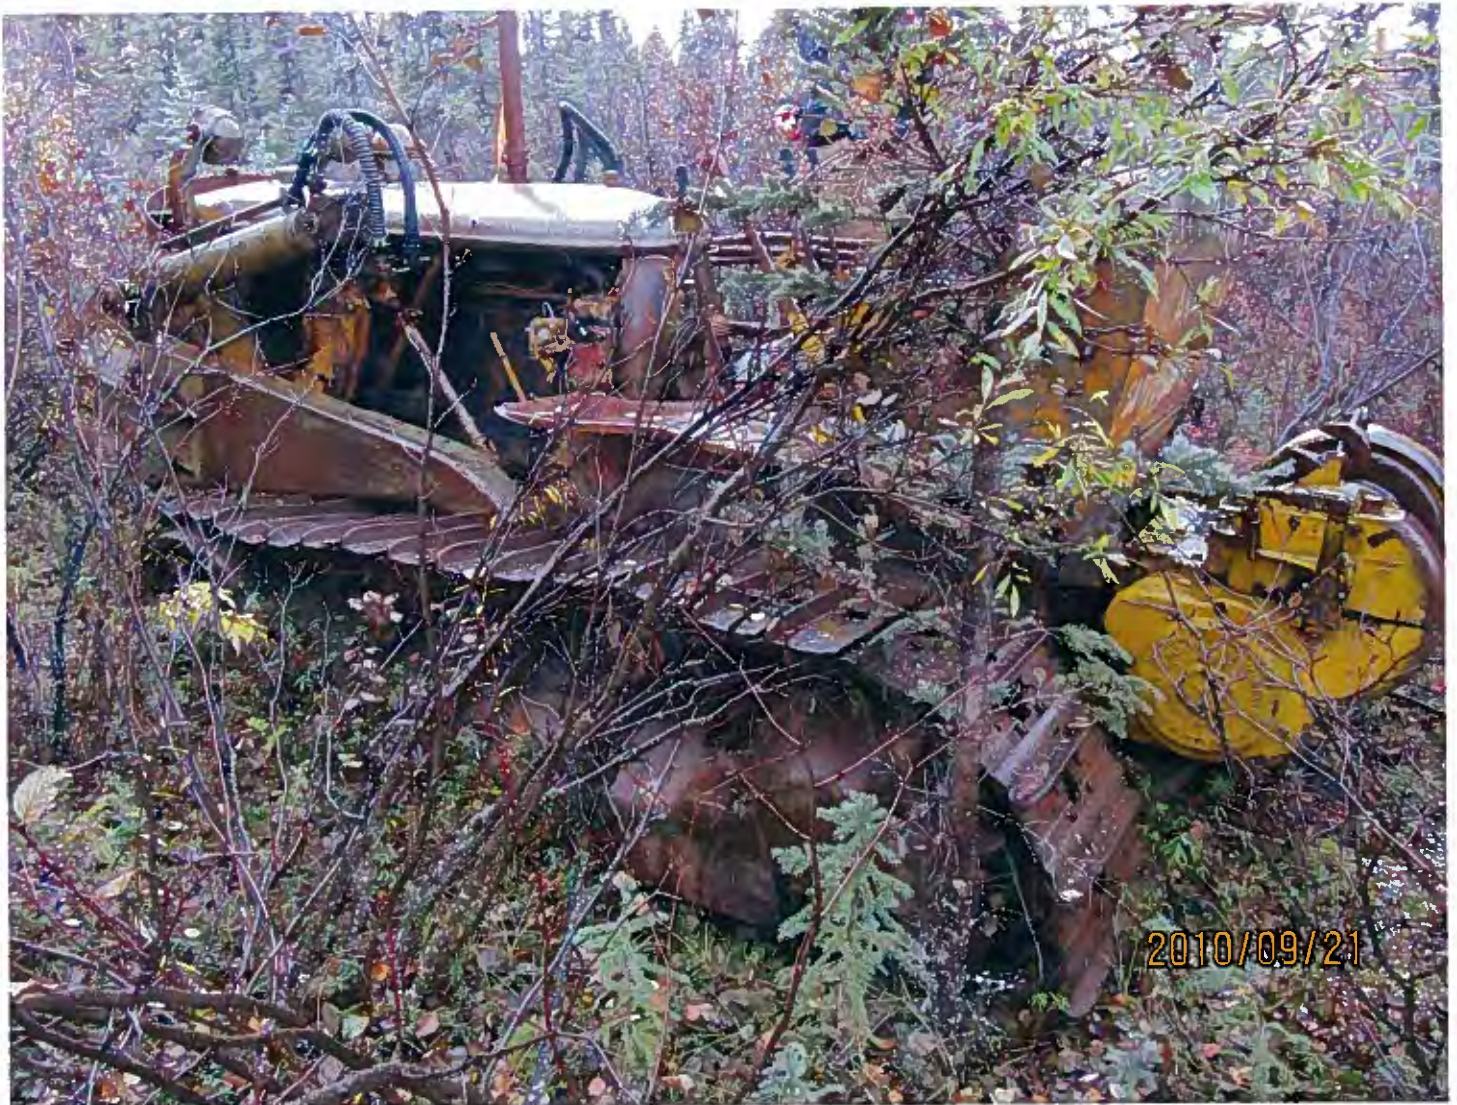
W2009X0002 - INAC-CARD - North Inca
Small cat that will be removed this winter along an existing trail.

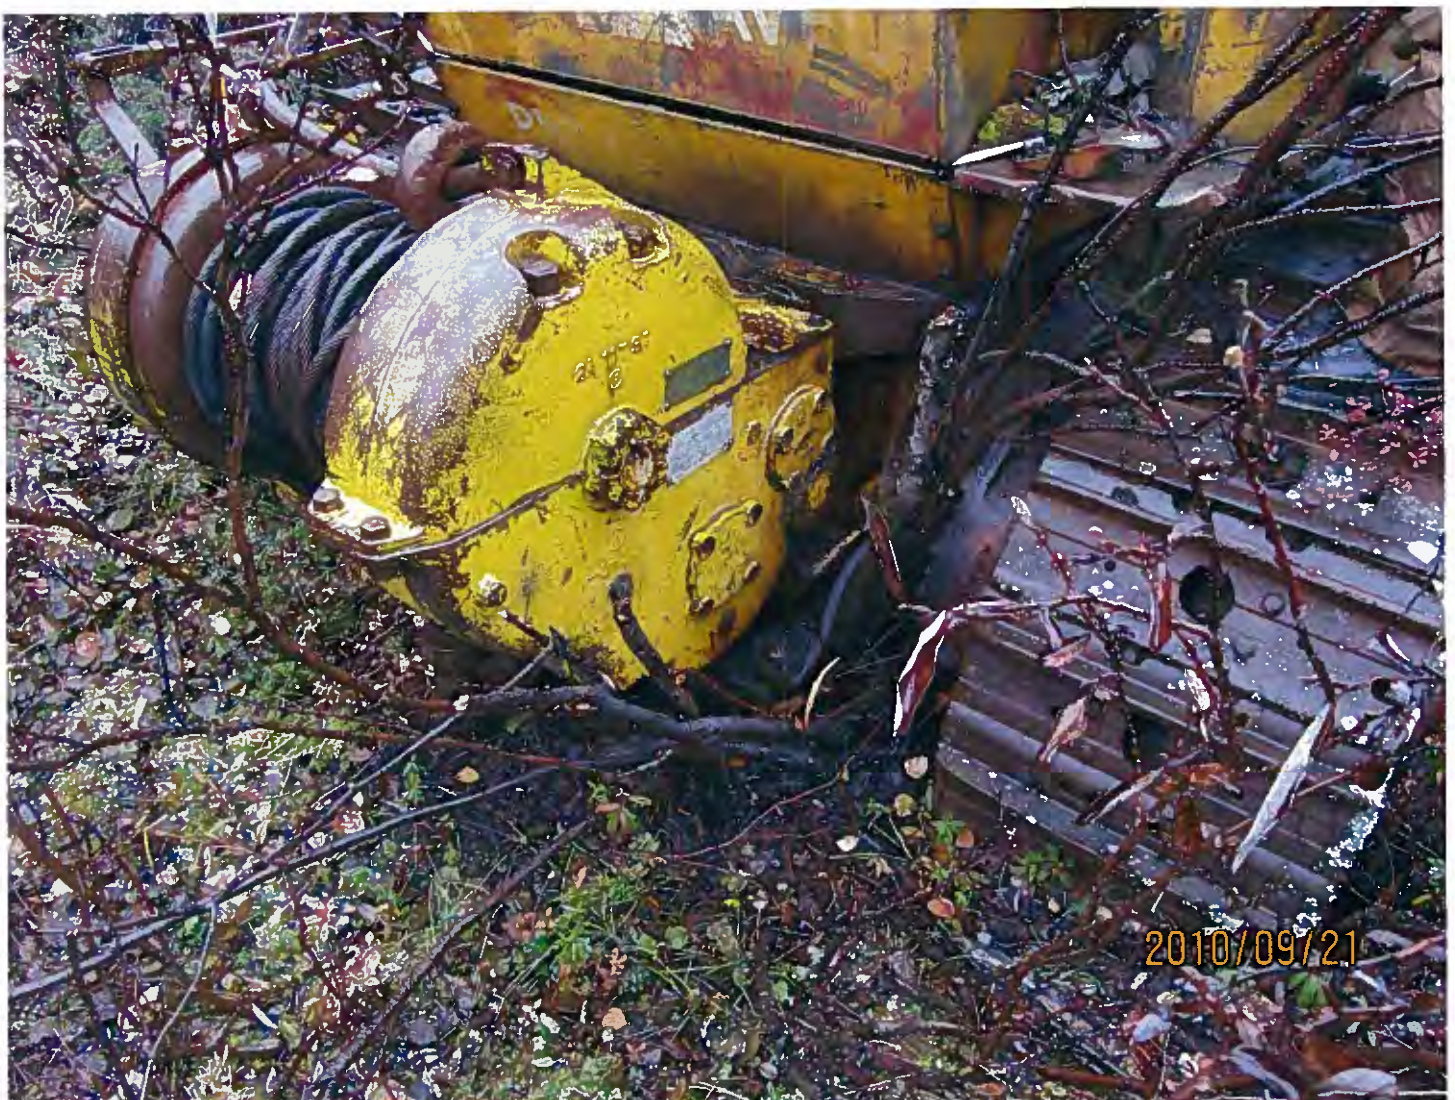
W2009X0002 - INAC-CARD - North Inca
Hydrocarbon impacted soils under the Cat require cleanup for proper off site disposal.
