#16 Yellowknife Airport
Yellowknife, NWT
X1A 3T2

September 22nd, 2010

**Re: Land Use Permits W2009X0007 and W2009X0002
 Site Remediation
 Colomac Mine Site and North Inca Advanced Exploration Site Remediation, NT**

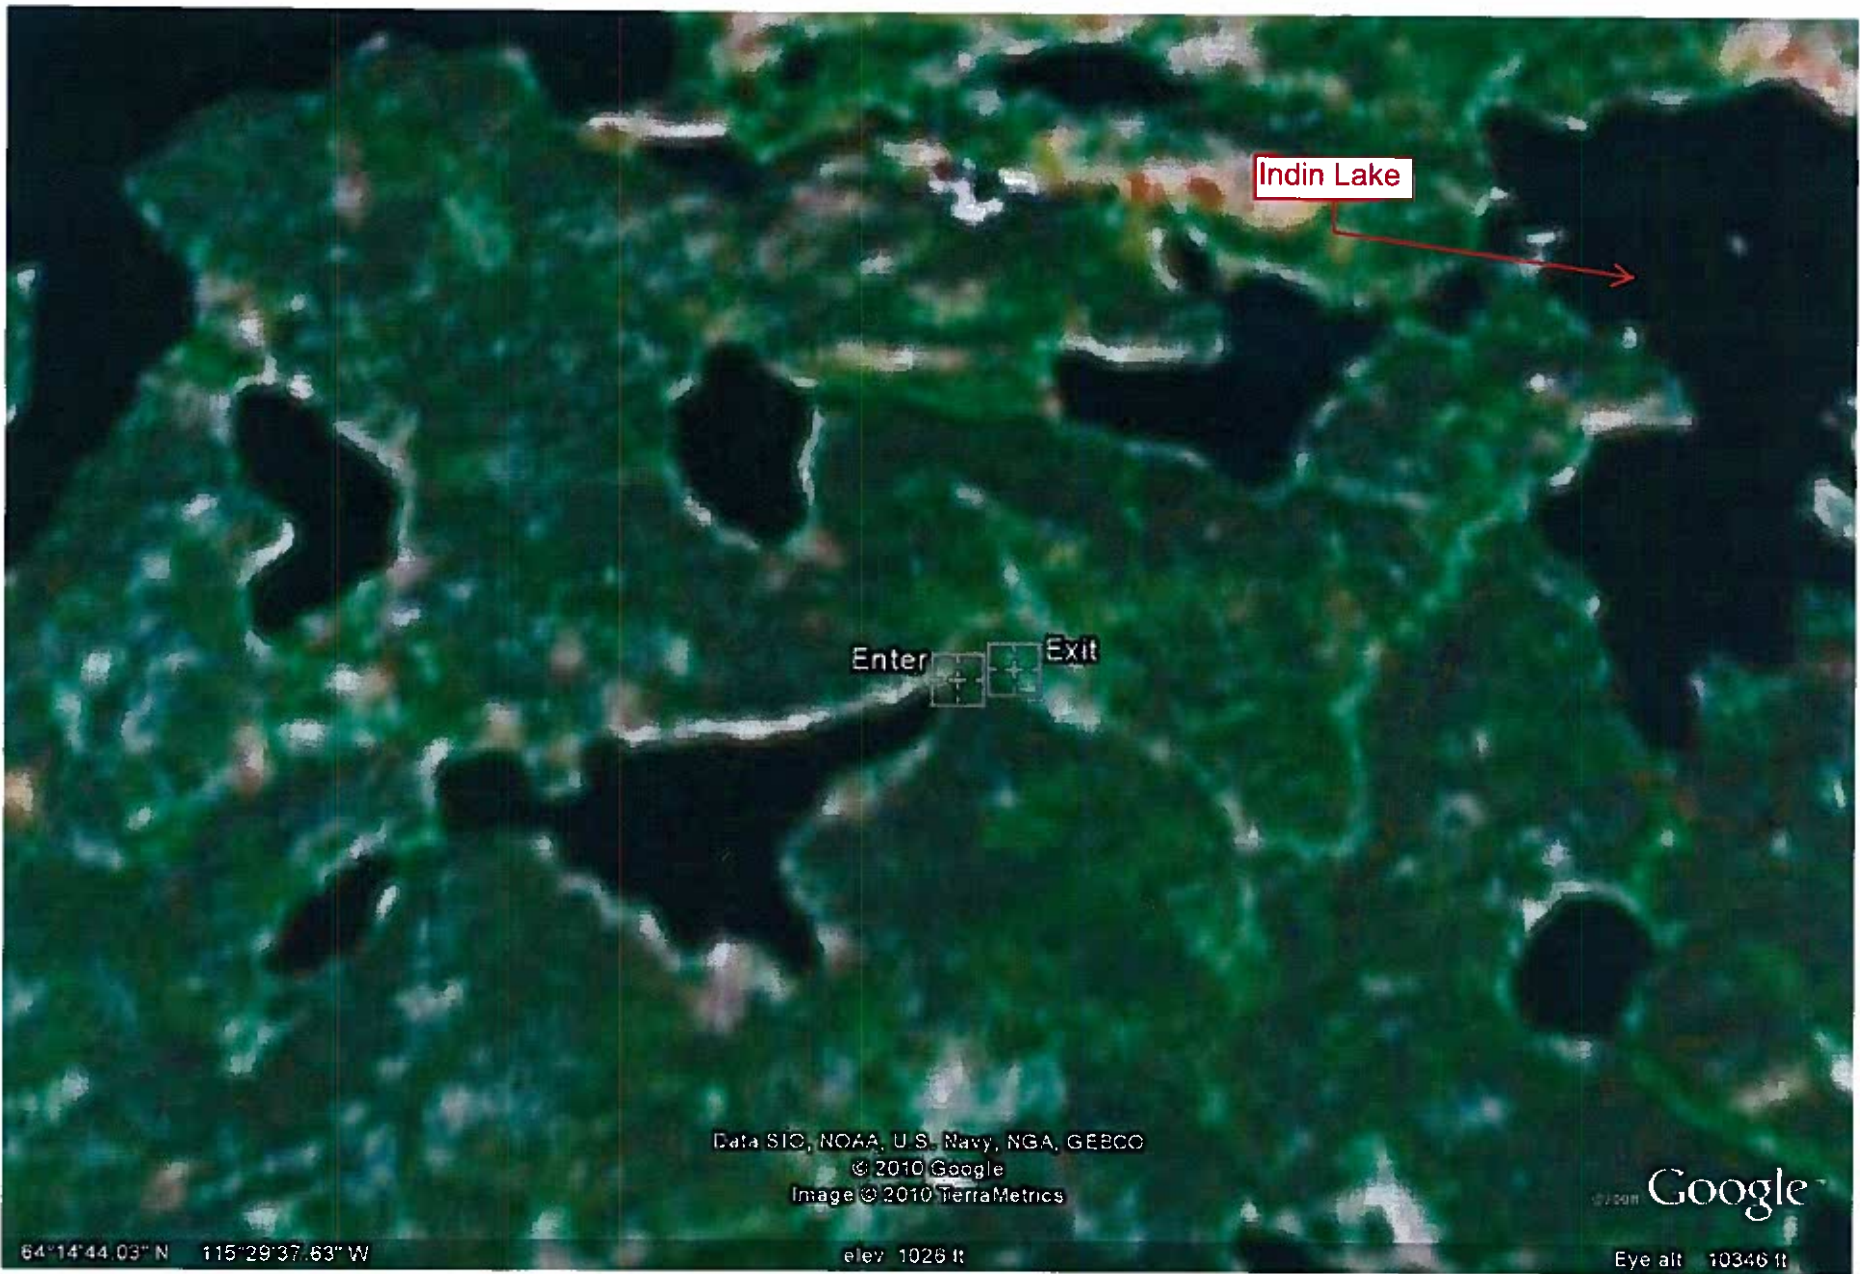
The Inspector does not foresee any major concerns with the proposed route re-alignment as it is approximately 600 feet in length and through an area that is sparsely treed for the most part. Prior to any work being conducted on this new route, the Permittee must ensure that this proposed route will be conducive to use by heavy haul trucks, improve the line of sight along this section of portage, and ultimately reduce the likelihood of an accident or rollover from occurring, which is the concern at the existing section of the portage.

Existing and proposed bypass are circled.

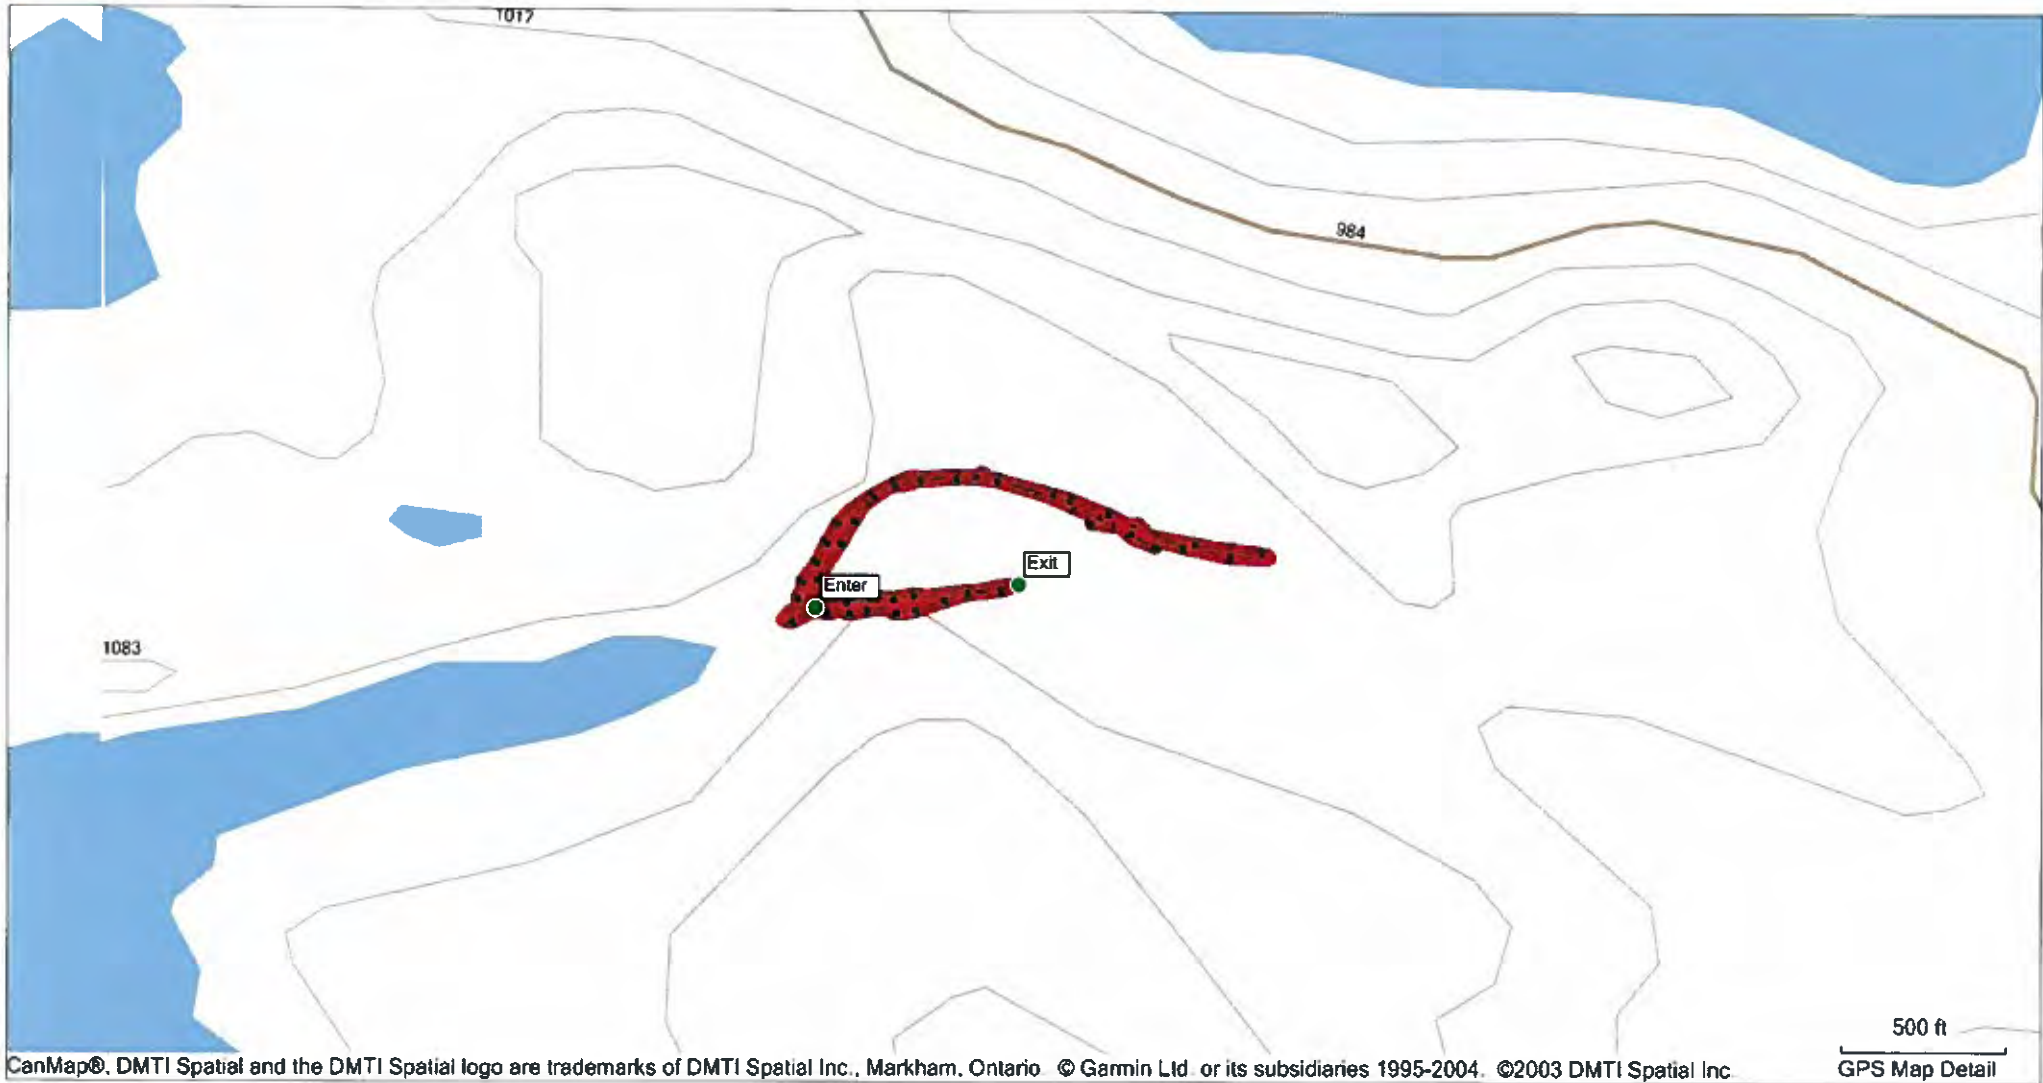
500 ft
GPS Map Detail

The perimeter of the bulk sample location east of Hewitt Lake was inspected and only three drill holes were observed that were not sealed. The location of these sites is depicted on the attached map and if the Permittee requires the waypoints, the undersigned Inspector can provide them.

At these two locations, lengths of drill steel were observed, and if the Permittee is returning to this portion of the land use area to address the unsealed drill holes, they must be removed for proper disposal at an approved disposal facility. Also, if any other garbage or debris is observed it must be removed for proper disposal.
