# **Erosion, Sediment and Drainage Control Plan 2010**

**Aboriginal Engineering Limited**

## ***Erosion, Sediment and Drainage Control Plan 2010***

**PROJECT ID:** *TUNDRA MINE PHASE 2 REMEDIATION*

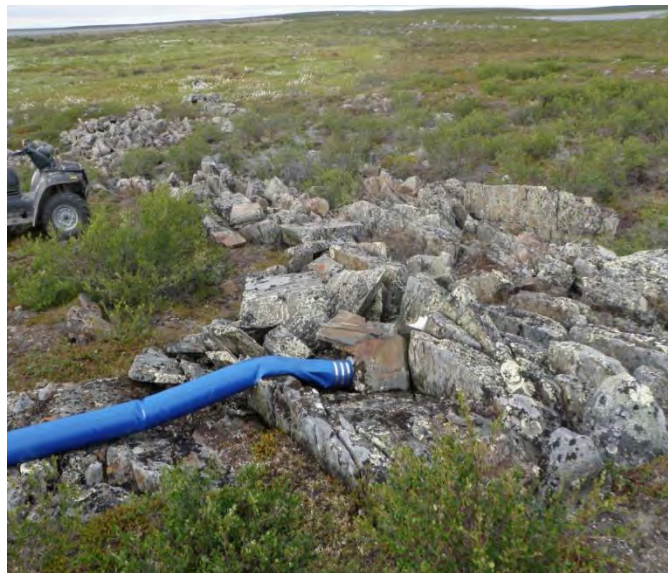
This rock outcrop wetland location was chosen last year and did not have any visual erosion impact, nor did it increase water levels at downstream locations for the duration of the water treatment season; therefore, we would like to use this location again this year. Below is a picture from last treatment season of the discharge location at Hambone Lake.

erosion at Hambone Lake. We would like to put one discharge line at the same location as last year – which was at an outcrop of fractured rock in the wetlands draining into Hambone Lake. We will find another appropriate fractured rock pile in the wetlands for the second discharge location. By discharging at an outcrop in the wetlands prior to Hambone Lake, it will have the following advantages:

- maximize energy dissipation prior to entering the wetland and maximize the filtration through the wetland prior to entering Hambone Lake.
- The rock acts as a water diffuser so when the discharge water reaches the wetland, the velocity is tranquil and the flow has been reduced to laminar with little to no erosive force.
- Longer water lines require a higher pressure to move the water. By reducing the length of the line, the pressure will reduce, which will minimize and mitigate against line blowouts along the discharge.
